Lotus Elan M100 Service Bulletins
Series 1 and Series 2 1990 - 1996

SERVICE BULLETIN

TITLE: Replacement of headlamp flap 'J' links.

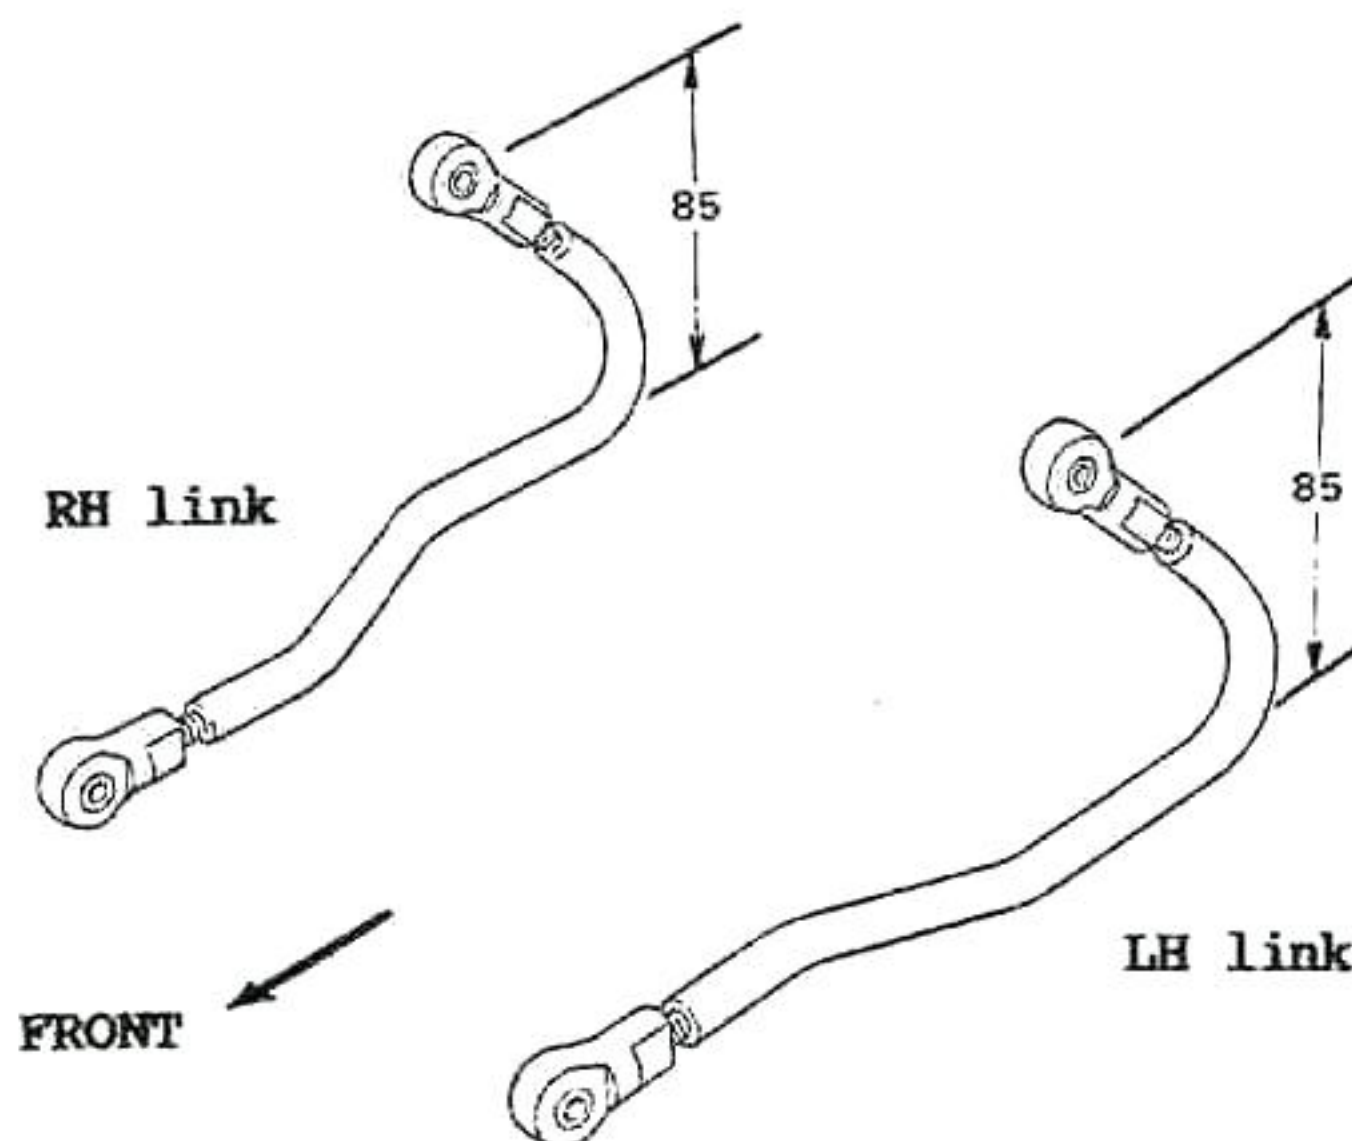
REASON: Incorrect material specification of some links may result in distortion of link and faulty operation of headlamp mechanism.

Before fitting the 'J' links, ensure that each link is correctly identified and adjusted as shown in the diagram.

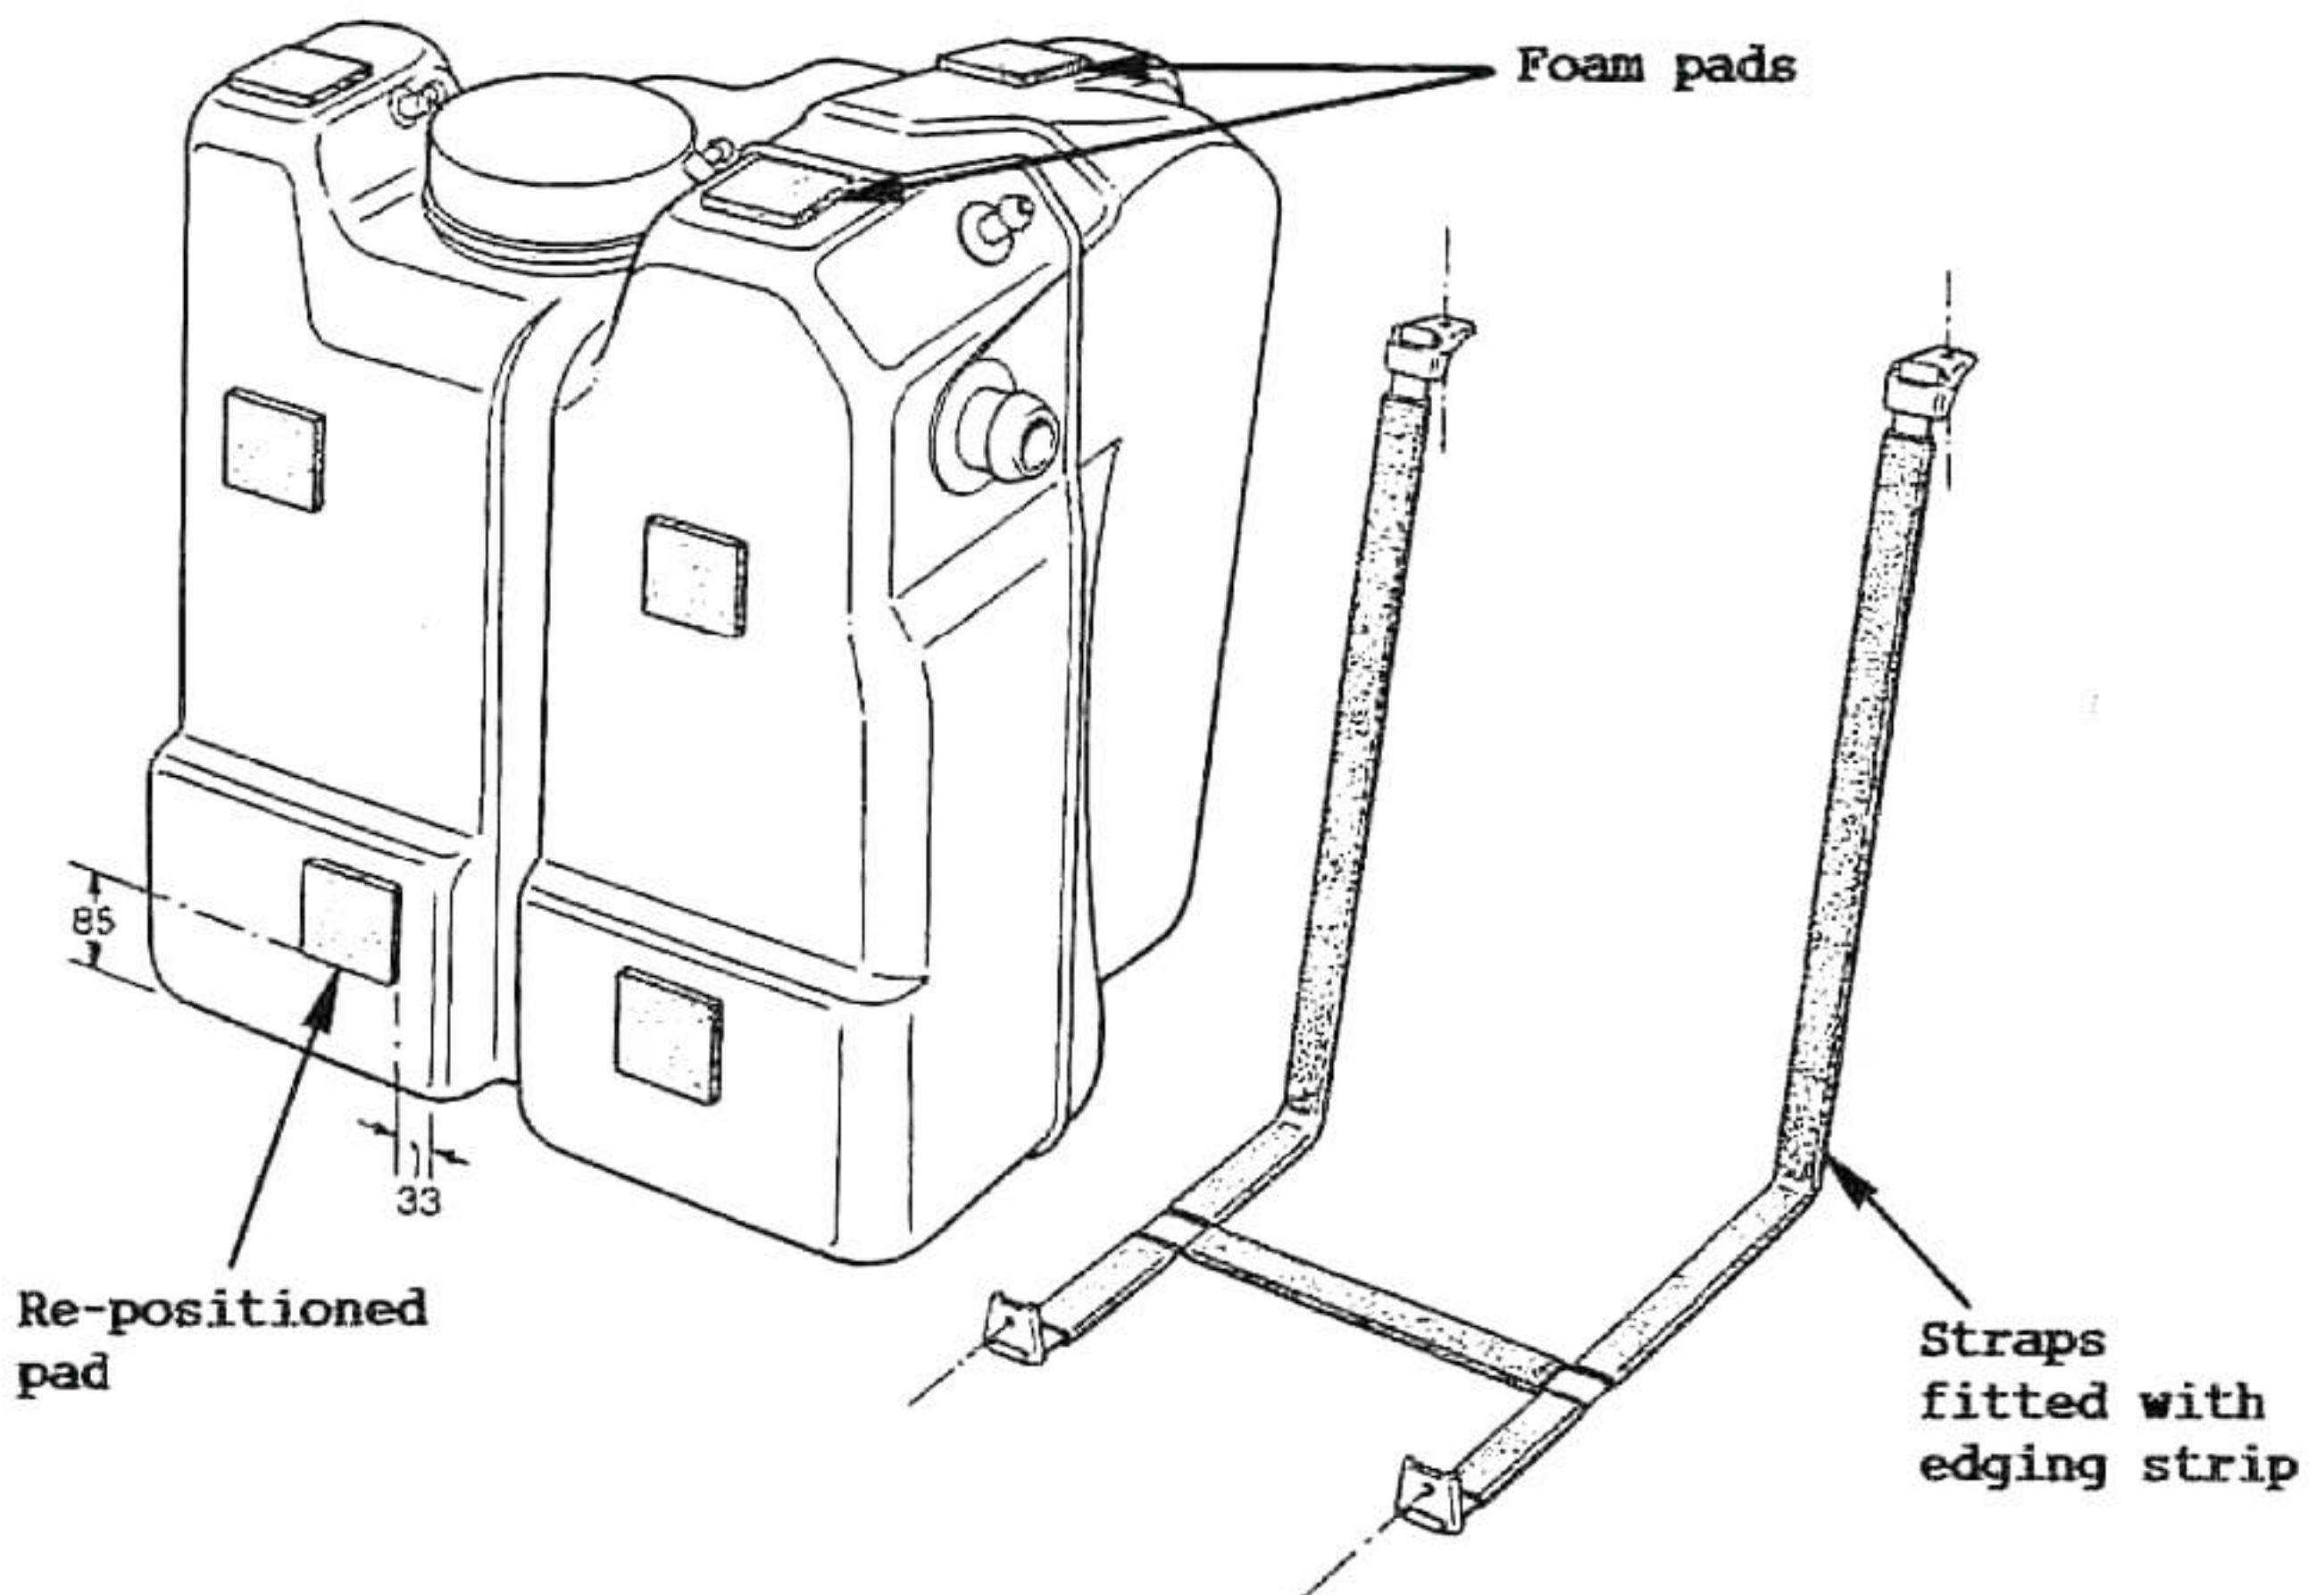
REASON: Revised moulding with improved resistance to joint line leakage.

8. Release the locknut from the underside of the two strap top fixing bolts, and unscrew each bolt. Swing down the two straps and carefully lower the tank, easing the filler stub through the body.
9. Transfer the balance pipe to the new tank, but leave one end disconnected.
10. Use Silastic RTV 732 adhesive (A036E6038) to secure the seven foam rubber pads to the new tank in the positions shown on the diagram. Note that all the positions except the RH lower position on the tank front face are indicated by moulded corner lines on the tank.

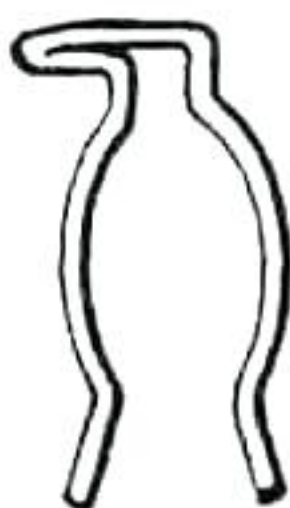
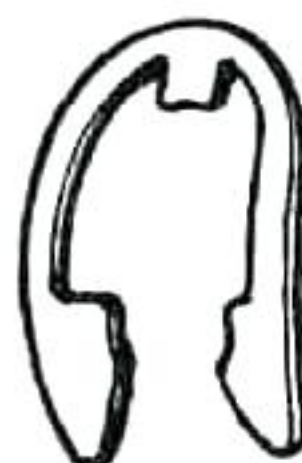
REASON: Improved gearchange cable security.
The outer sheath of each of the two gearchange cables, is retained at each end by a spring clip. The spring wire clip used until recently, has been replaced by a dished 'C' clip which offers greater assurance of correct fitment, and increased resistance to dislodgement from the effects of vibration or vigorous gearchange operation.

ACTION: If an old type gearchange cable abutment clip is found to be dislodged, or if for any other reason access to the clips is available, it is recommended that all four of the clips be replaced by the latest type. Note that the new clips are fitted with the concave side towards the abutment bracket.

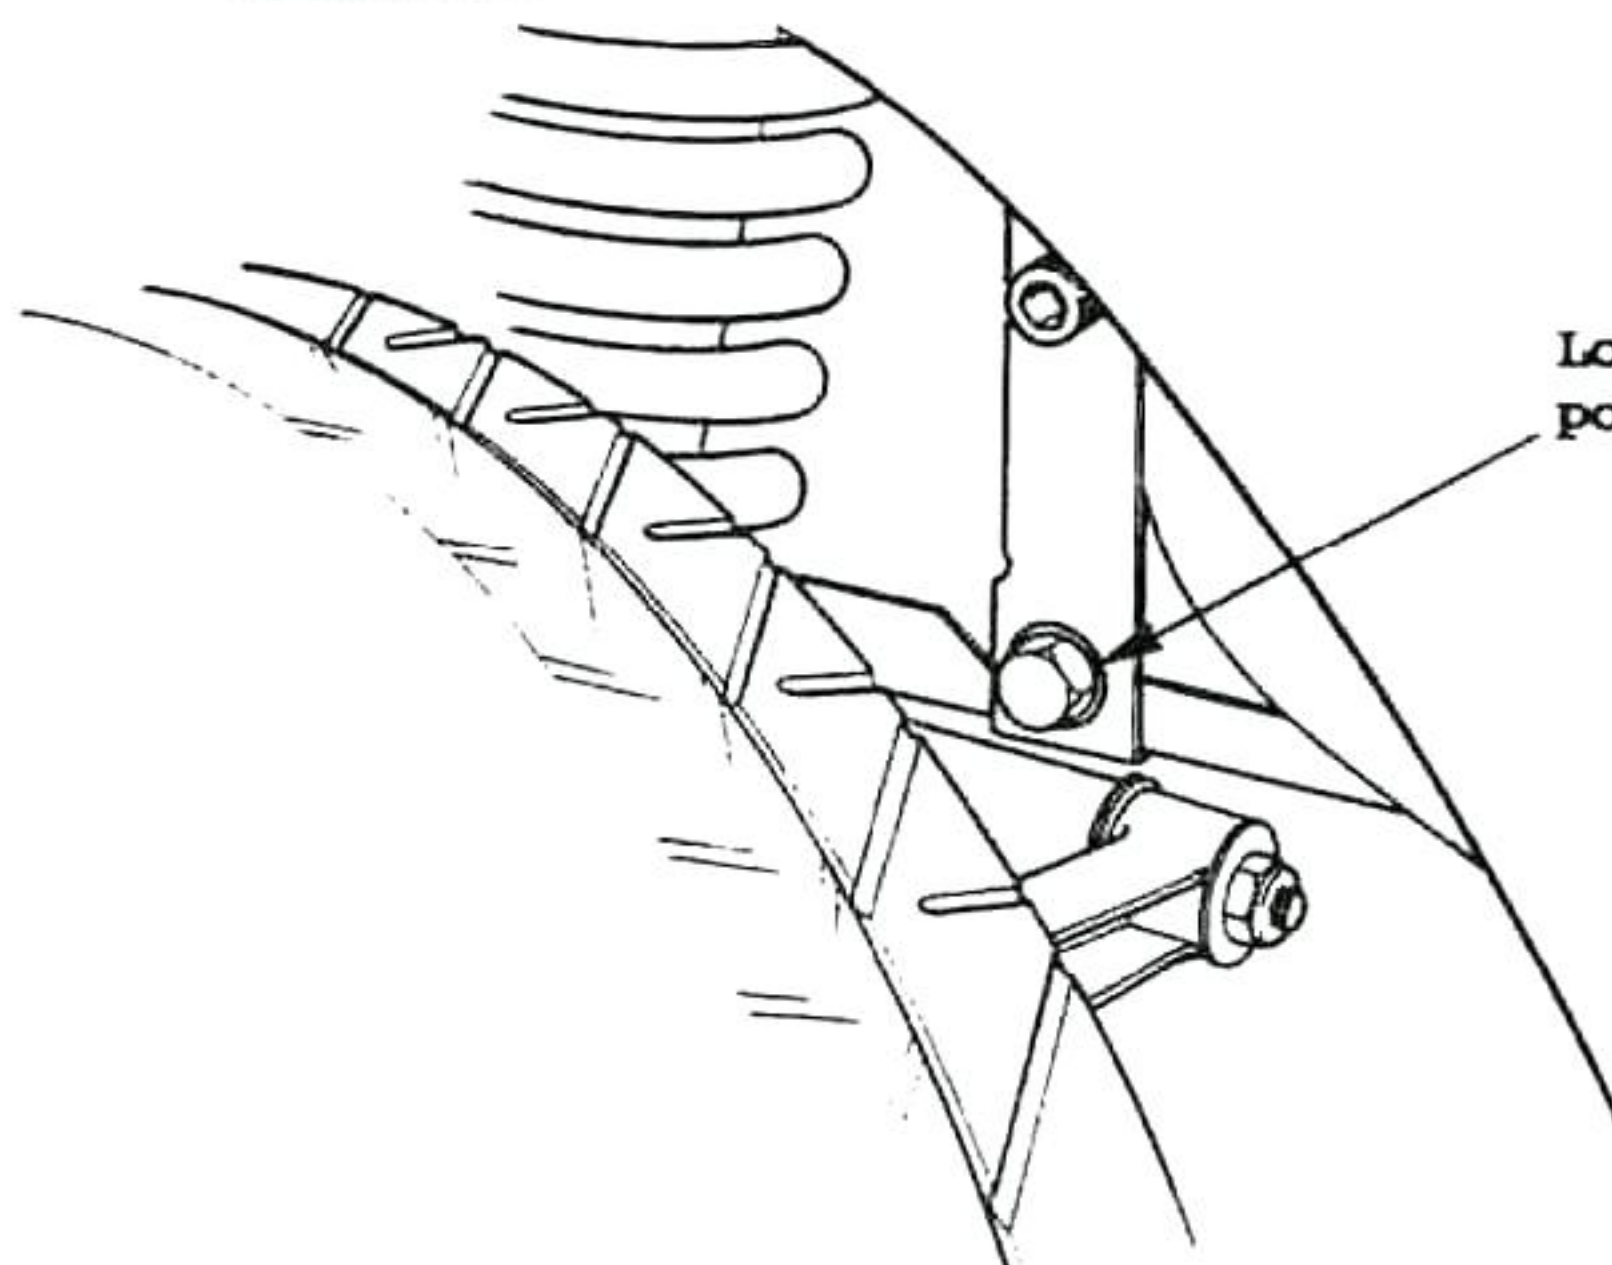
Longeron lower
positioning bolt

REASON: Bolts fitted may be below specification.
It has been found that on certain cars, the lower (longer) of the two taper seat bolts used to position each chassis longeron before the six socket head bolts are tightened, may have been from a batch identified as not meeting the correct material specification.

1. With the car on its wheels, turn the steering for improved access to the lower front bolt (hex head) securing the longeron to the chassis. Note that it is not necessary to release the wheelarch liner.
2. Remove the bolt, and replace with a new bolt B100A0438F. Torque tighten to 120 Nm (89 lbf.ft).
3. Mark the head of the new bolt with BLUE paint. Note that the old bolt may have been marked with GREEN paint.
4. Repeat for the opposite side.
