Lotus Elan M100 Service Bulletins
Series 1 and Series 2 1990 - 1996

SERVICE BULLETIN

TITLE: Replacement of headlamp flap 'J' links.

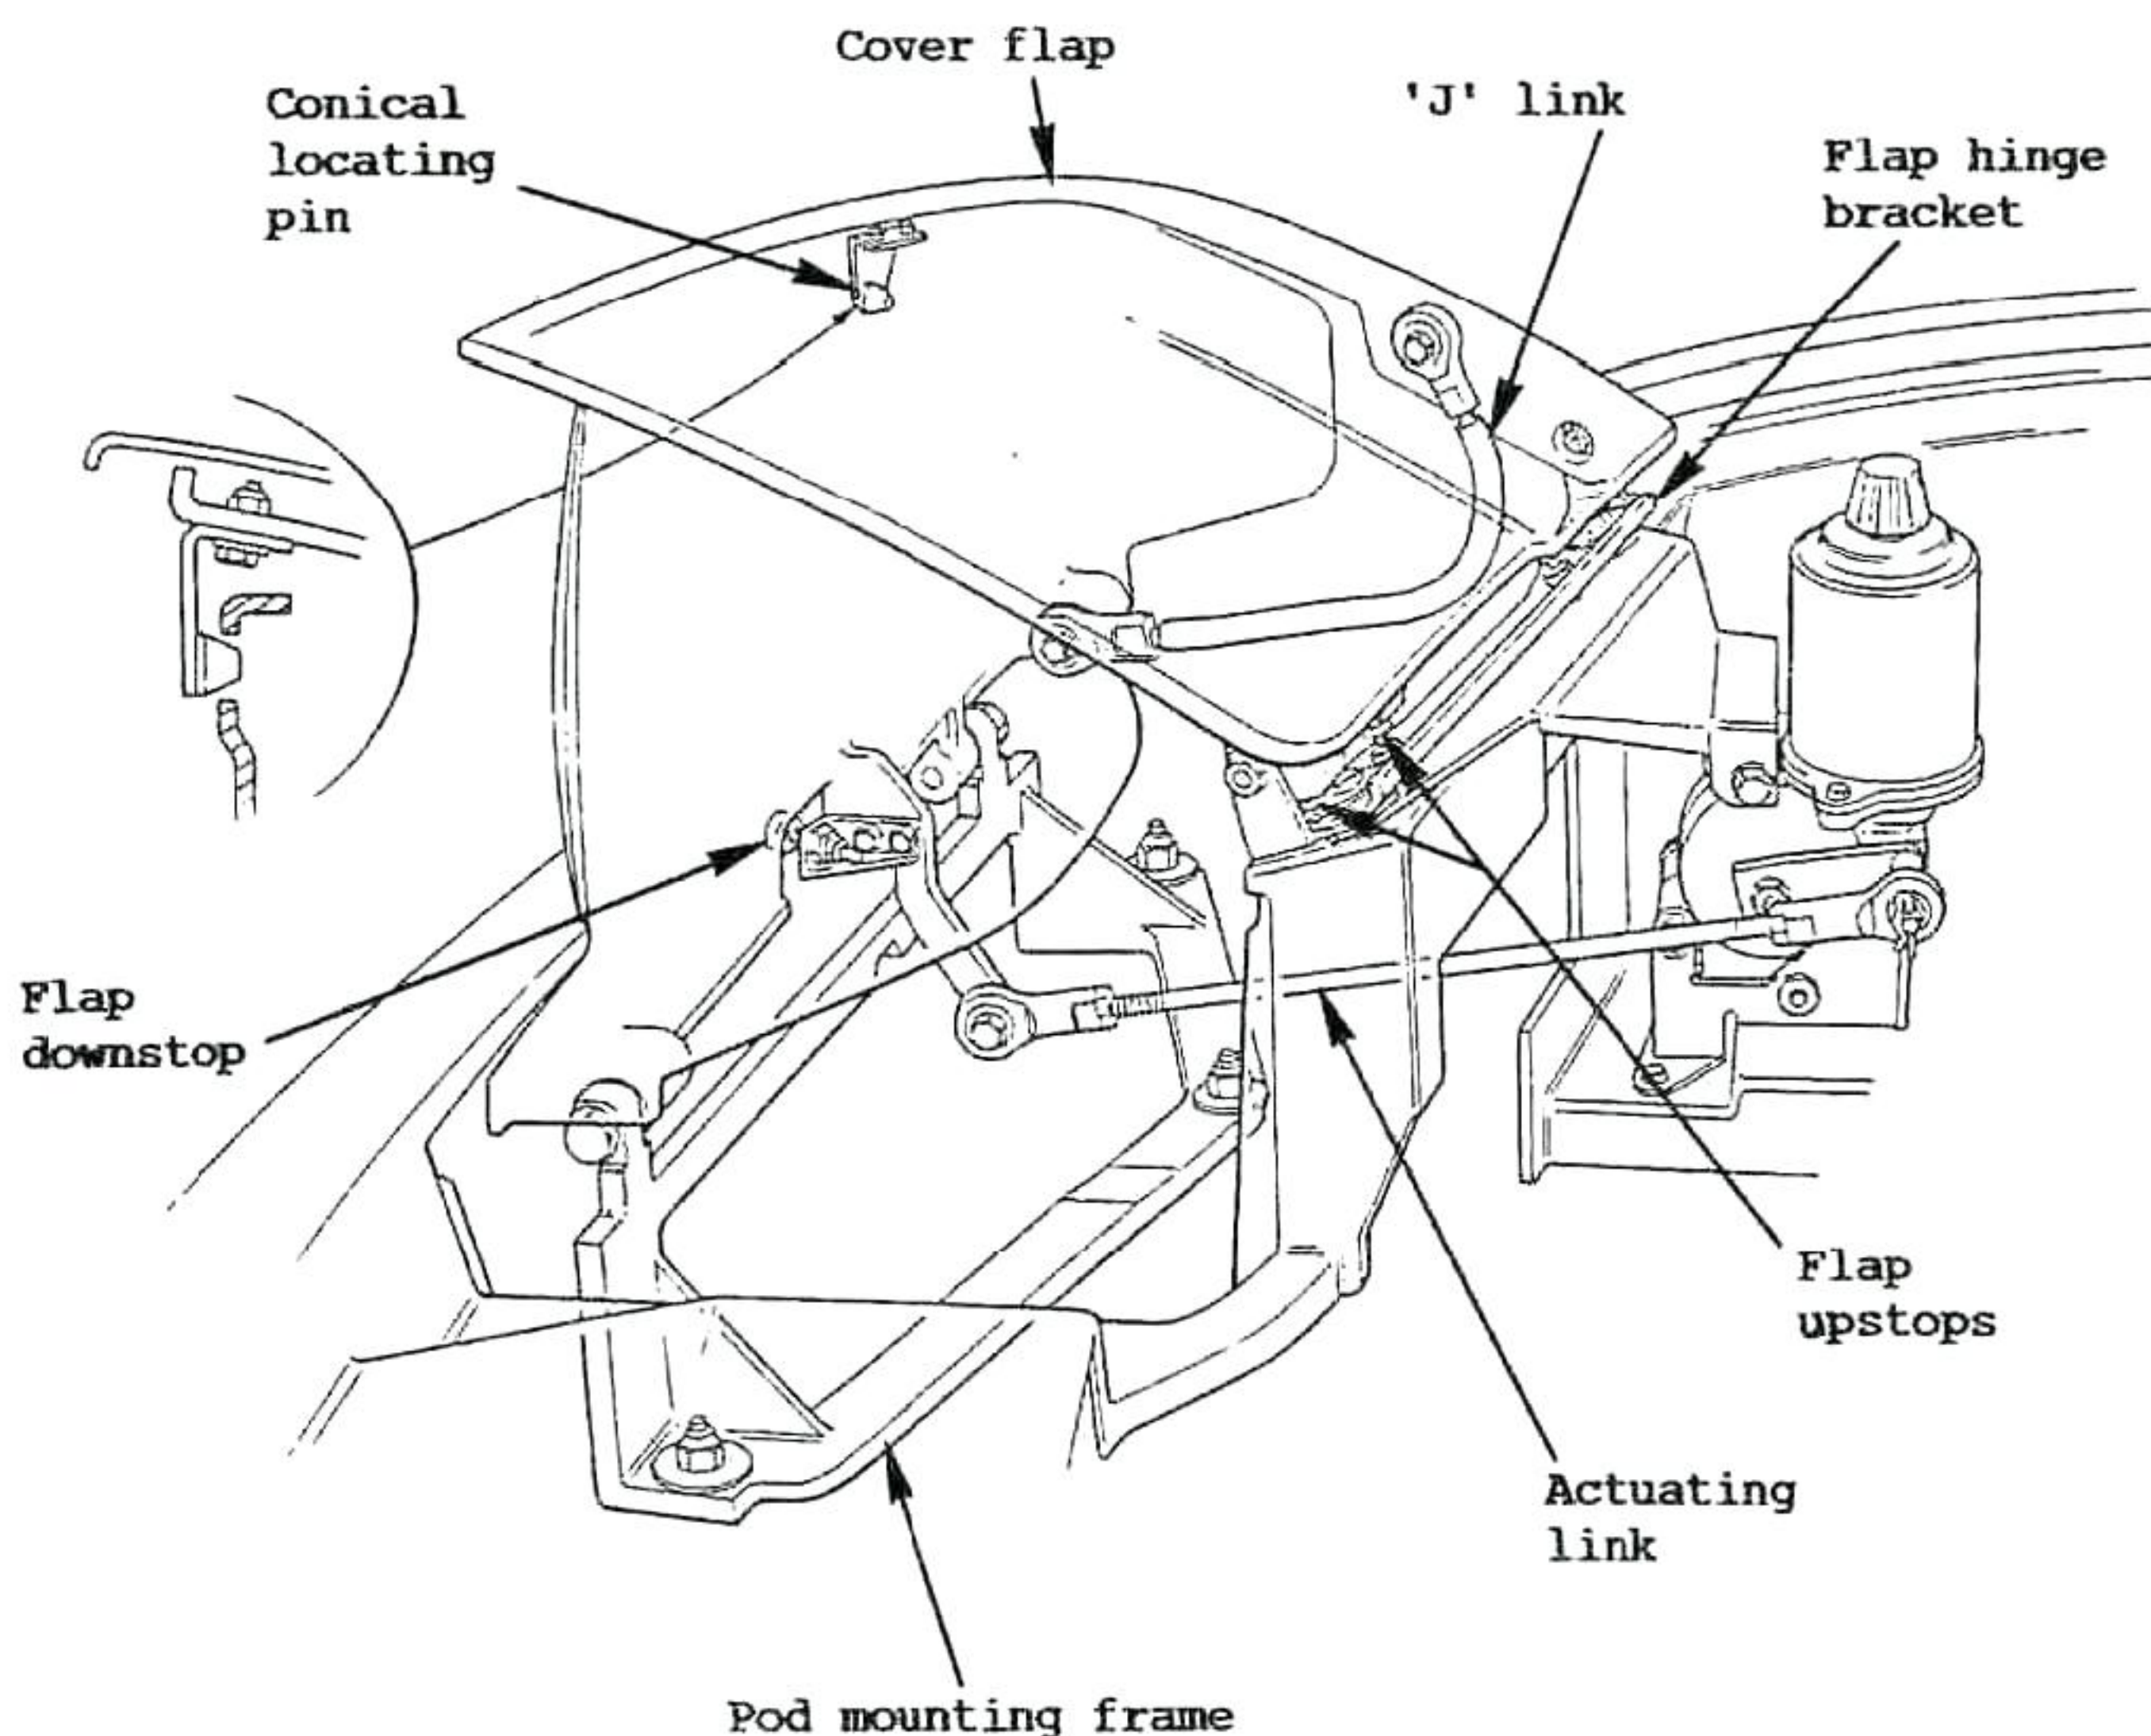
REASON: Incorrect material specification of some links may result in distortion of link and faulty operation of headlamp mechanism.

ACTION: At the next opportunity (i.e. next time the vehicle is on the dealer premises), replace the headlamp flap 'J' links on all 1990 model year Elan and Elan S.E. models in the following VIN range:

Before fitting the 'J' links, ensure that each link is correctly identified and adjusted as shown in the diagram.

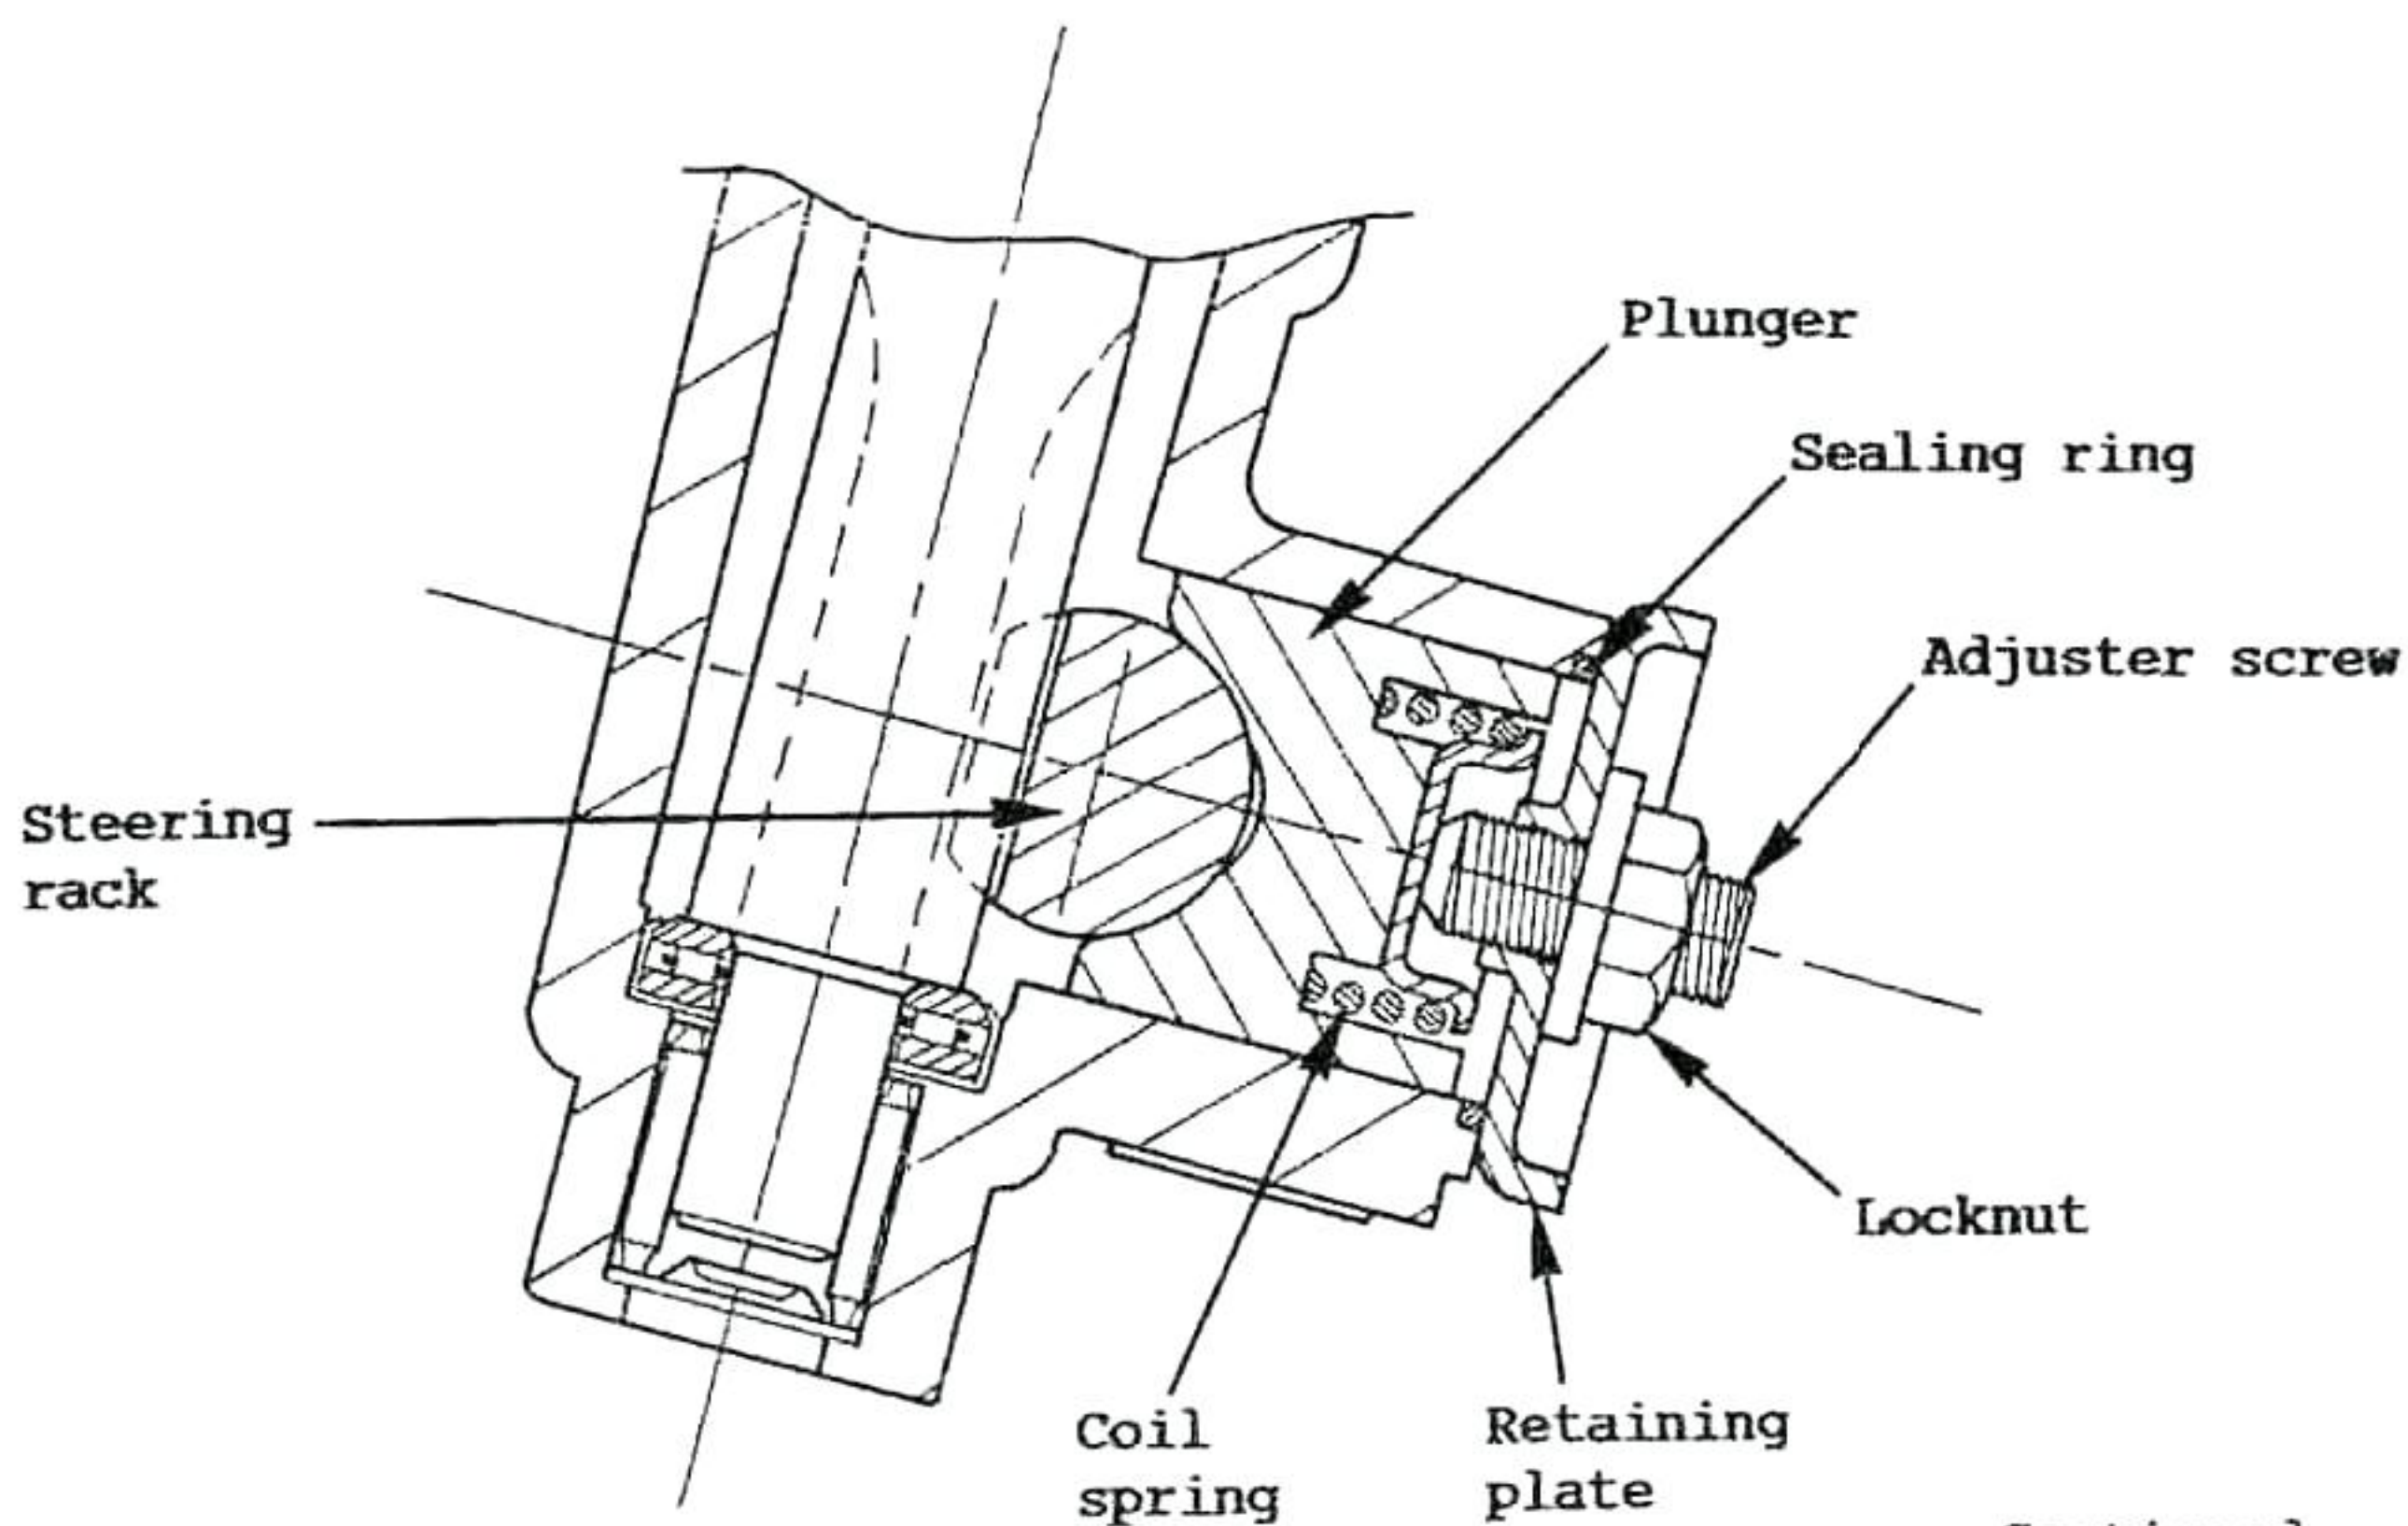
TITLE: Replacement of steering rack spring plunger.

5. Refit the spring and spring cup, and check that the sealing ring is correctly positioned on the rack housing before fitting the retaining plate with its two screws and shakeproof washers. Torque tighten the two fixings to 23 Nm (17 lbf.ft).

6. Adjust the spring plunger:
 - Tighten the adjusting screw until resistance is felt.
 - Back off the screw the minimum amount necessary so that when the rack is moved through its full travel (by turning a road wheel) no increase in resistance (tight spot) can be felt.

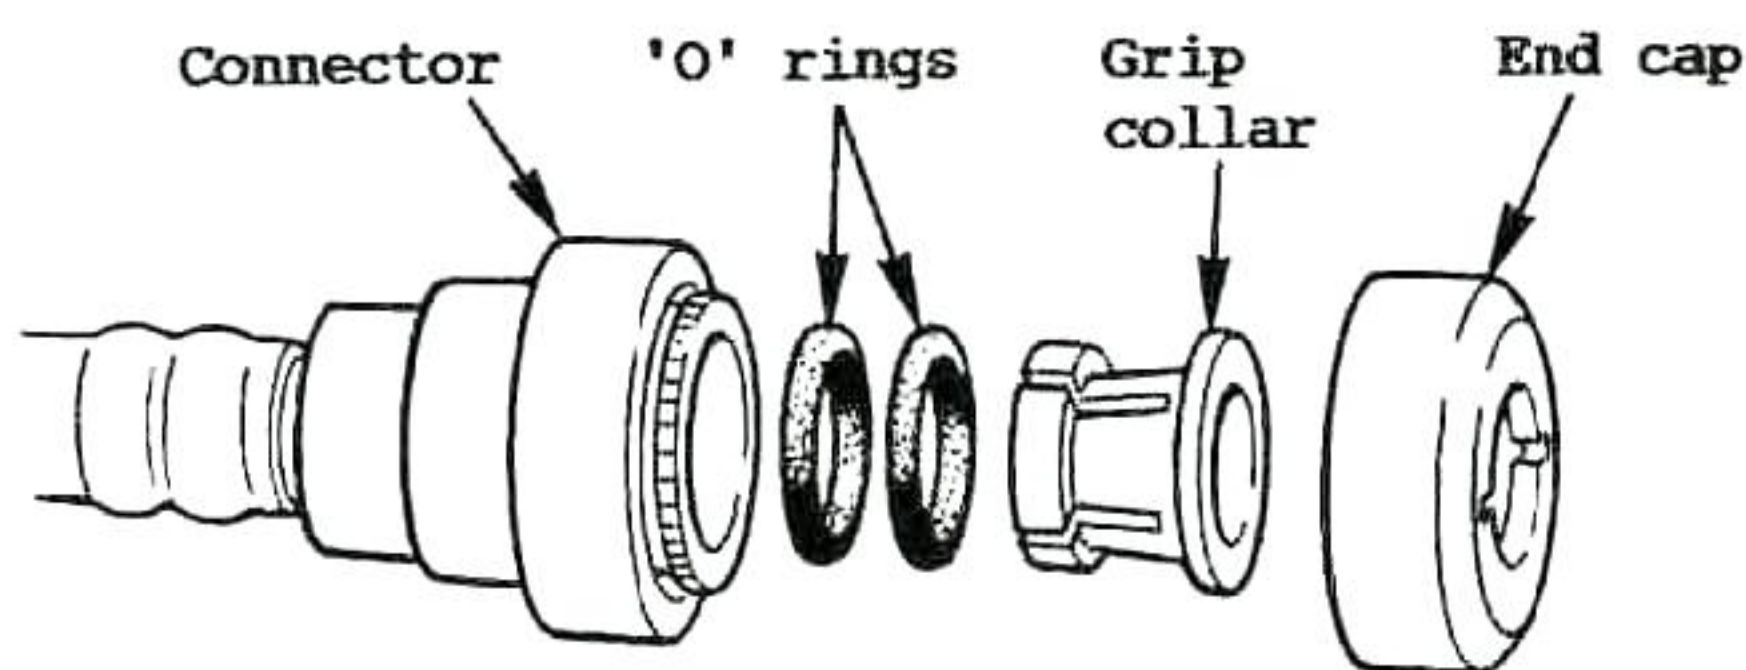
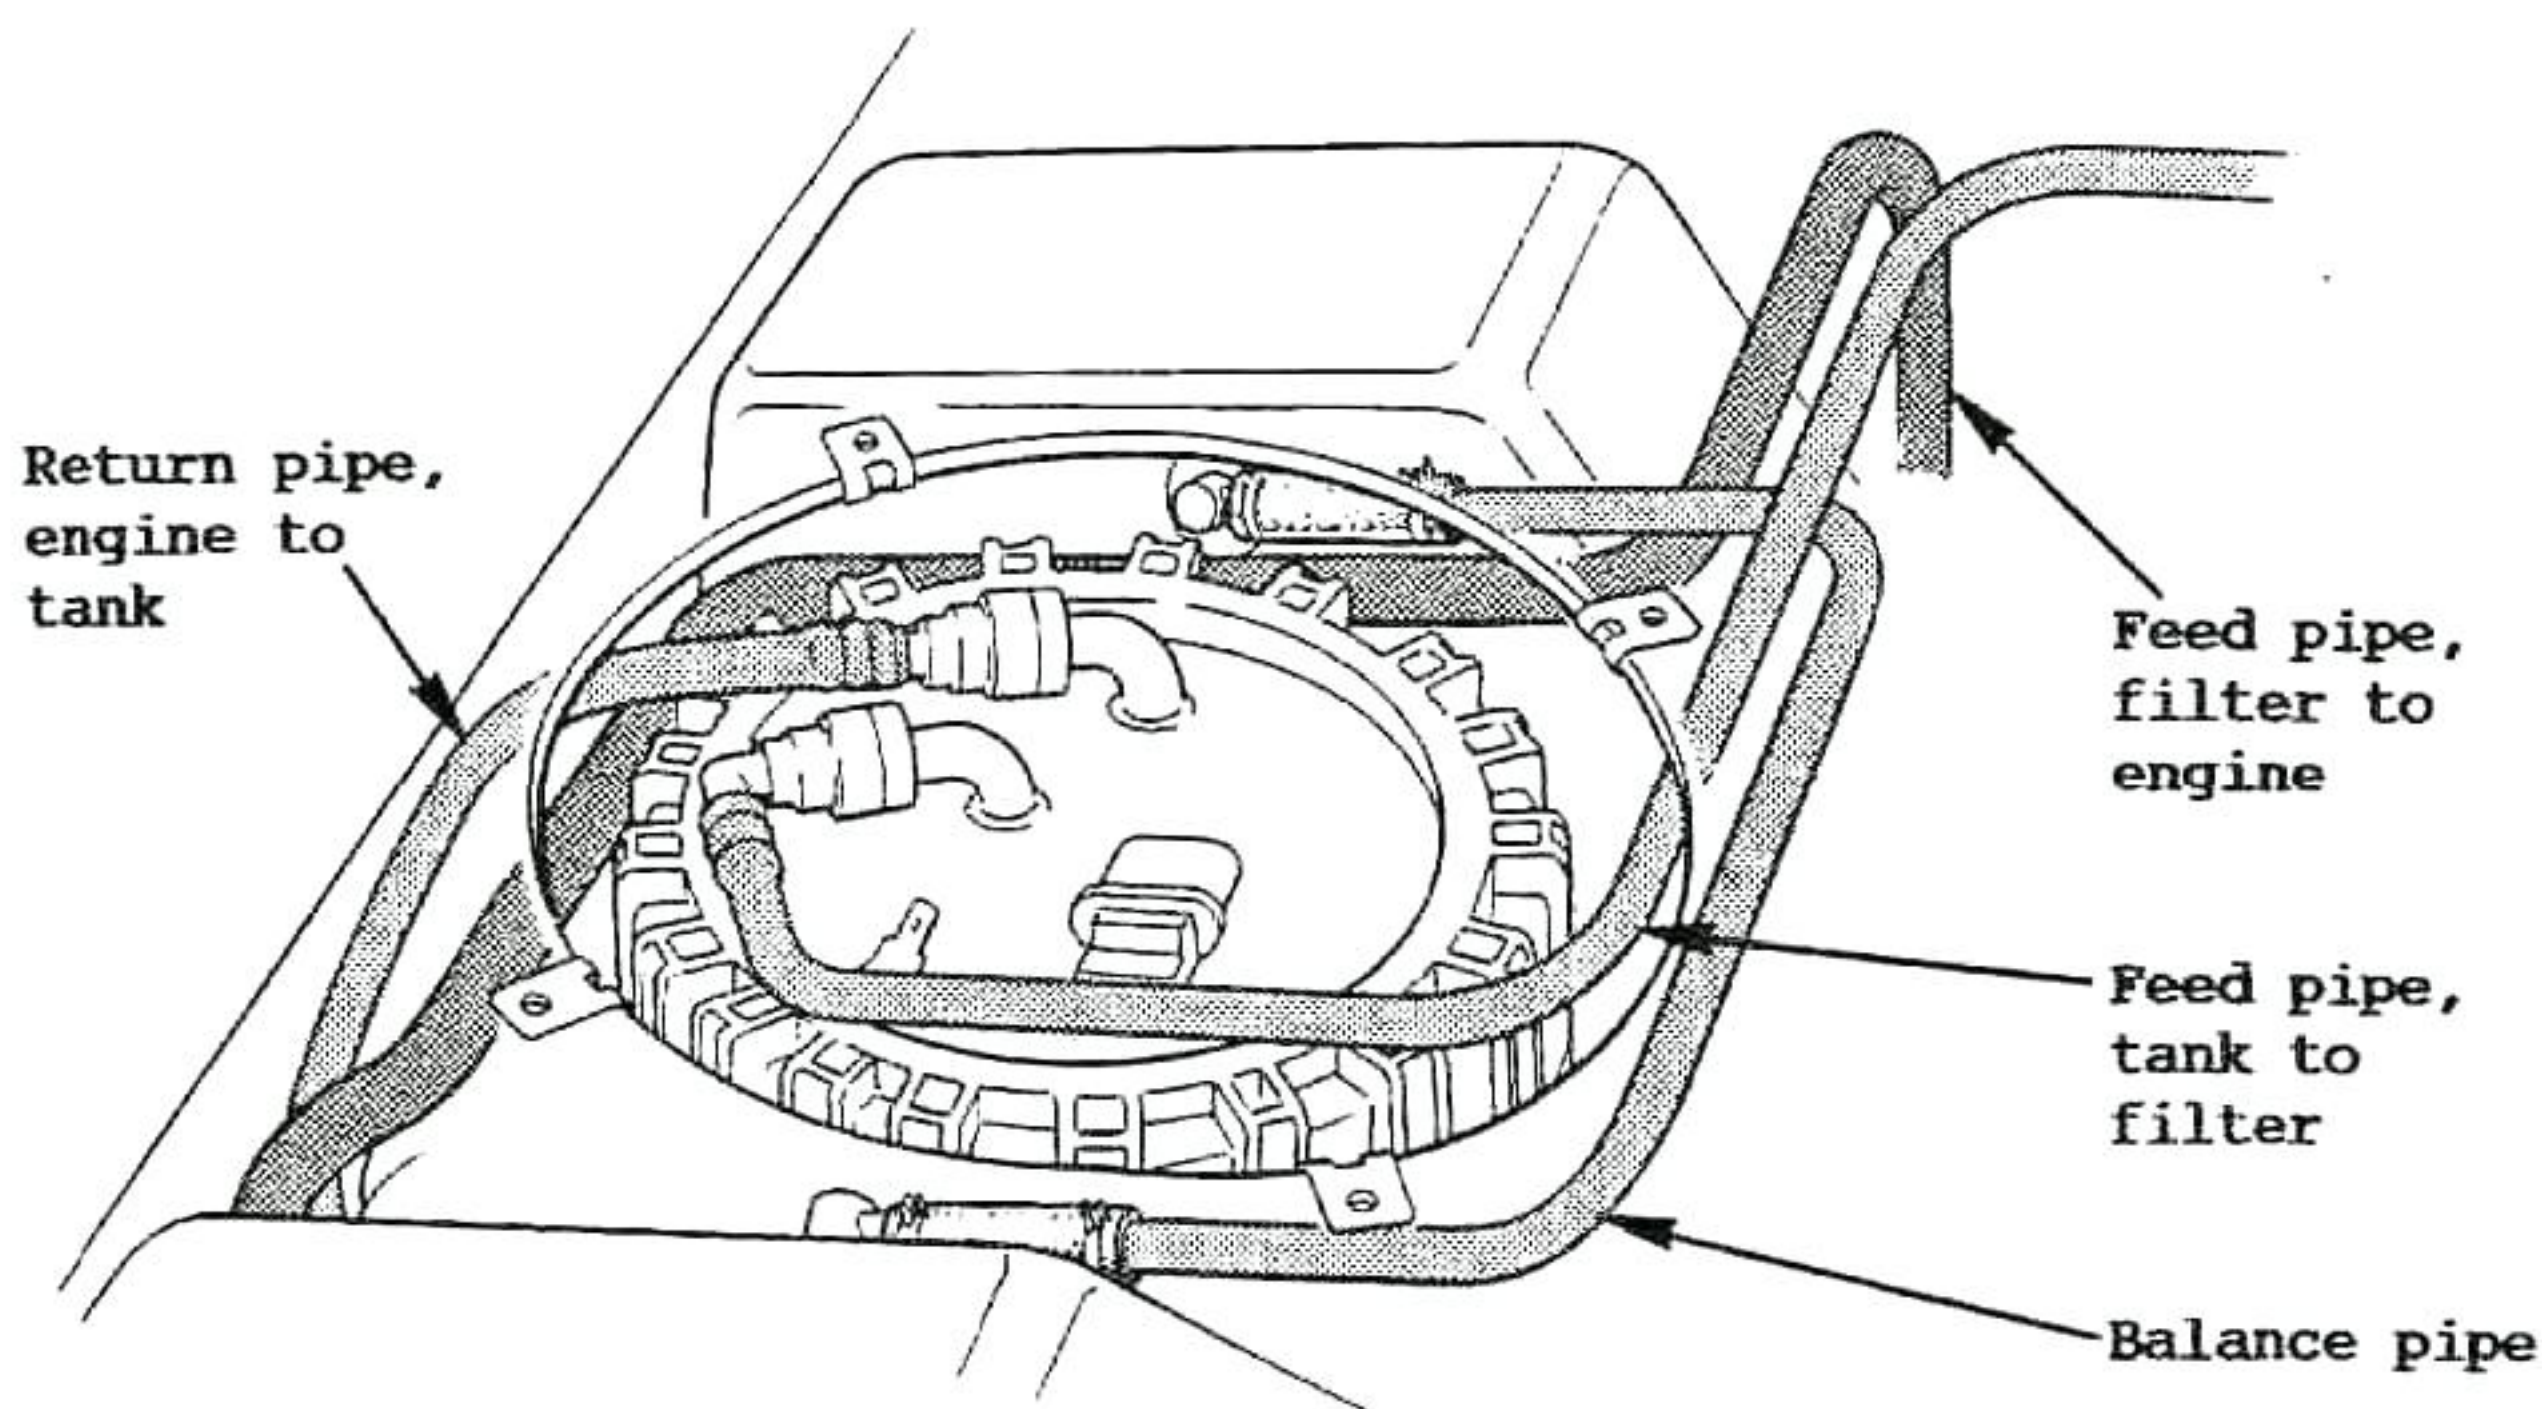
TITLE: Replacement of fuel tank.

REASON: Revised moulding with improved resistance to joint line leakage.

2. Fit the tank strap bolts taking care not to cross thread, and hold the weld nuts with an 18 mm deep socket to prevent the straps twisting whilst the bolts are torque tightened to 12 Nm (9 lbf.ft). Fit and tighten the lock nuts from beneath.
3. Fit the filler neck and filler breather tube grommets. Connect the filler hose, ensuring that the hose passes through the grommet, and secure with the hose clip. Fit and secure the filler breather hose.
4. Renew the 'O' rings in the fuel pipe connectors:
 - Prise off the end cap of the connector;
 - Pull out the gripper collar;
 - Remove the two 'O' rings from each connector;
 - Fit the two new 'O' rings supplied into each connector, and refit the gripper collar and end cap.

5. Check that the fuel feed pipe is correctly routed before connecting the balance pipe, and securing with the spring clip. Push the two fuel pipe connectors onto the tank spigots.

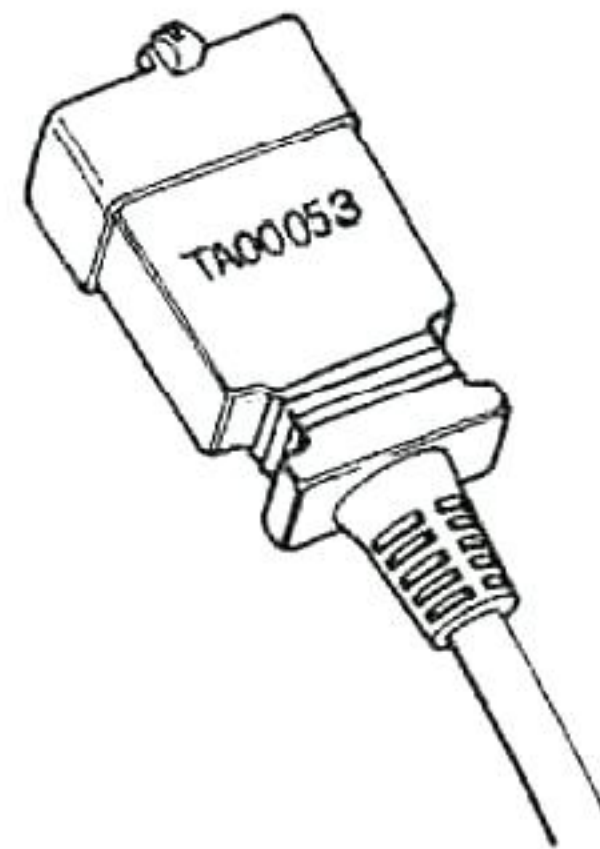
REASON: Greater all model compatibility, and inclusion of ABS brakes on '91 M.Y. Esprit range.
The 'Tech 1' is the electronic scanner tool used to diagnose faults in the engine management, supplementary inflatable restraint (USA), or ABS brake systems. The connector lead used between the Tech 1 and the Esprit's ALDL connector can, under certain circumstances, cause some problems with data retrieval on the M100 Elan. A new connector lead (T000T0897/2) overcomes this problem.
A new manual (Section JF) will be despatched shortly covering the braking system on 1991 M.Y. onwards Esprit models. These cars are fitted with Delco Moraine/NDH ABS IIIA anti-lock brakes, for which fault diagnosis may be performed using the Tech 1 tool in conjunction with a new ABS cartridge (T000T1115/1).

ACTION: Connector Lead
The new Tech 1 connector lead T000T0897/2 is identified by 'TA00053' embossed in gold lettering on the ALDL end connector.
This new lead will shortly be despatched to all dealers, who on receipt, should discard the old lead (T000T0897) to prevent confusion.

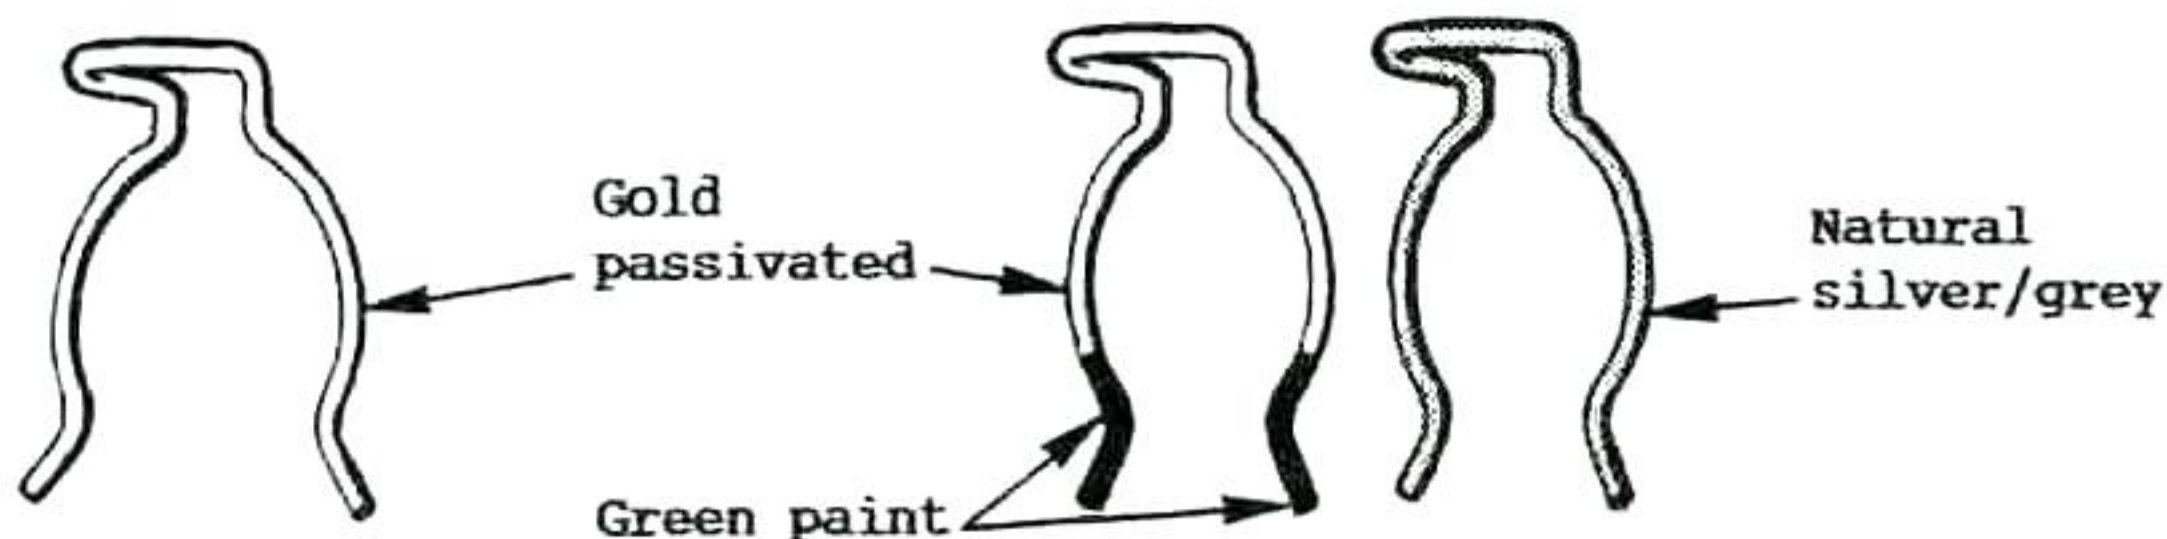
Non Preferred Type

Preferred Types

If non preferred type clips are found to be fitted at the transmission end, it should be assumed that these also will be fitted at the gear lever end, and all four clips should be replaced with preferred types (A100F6060F).

To replace the clips at the gearchange lever end, it is necessary to release the transmission end of the cables, before removing the centre tunnel trim panel, and withdrawing the gearchange mechanism/cable assembly into the car sufficiently to permit access. Full details may be found in Service Notes section FF.5.

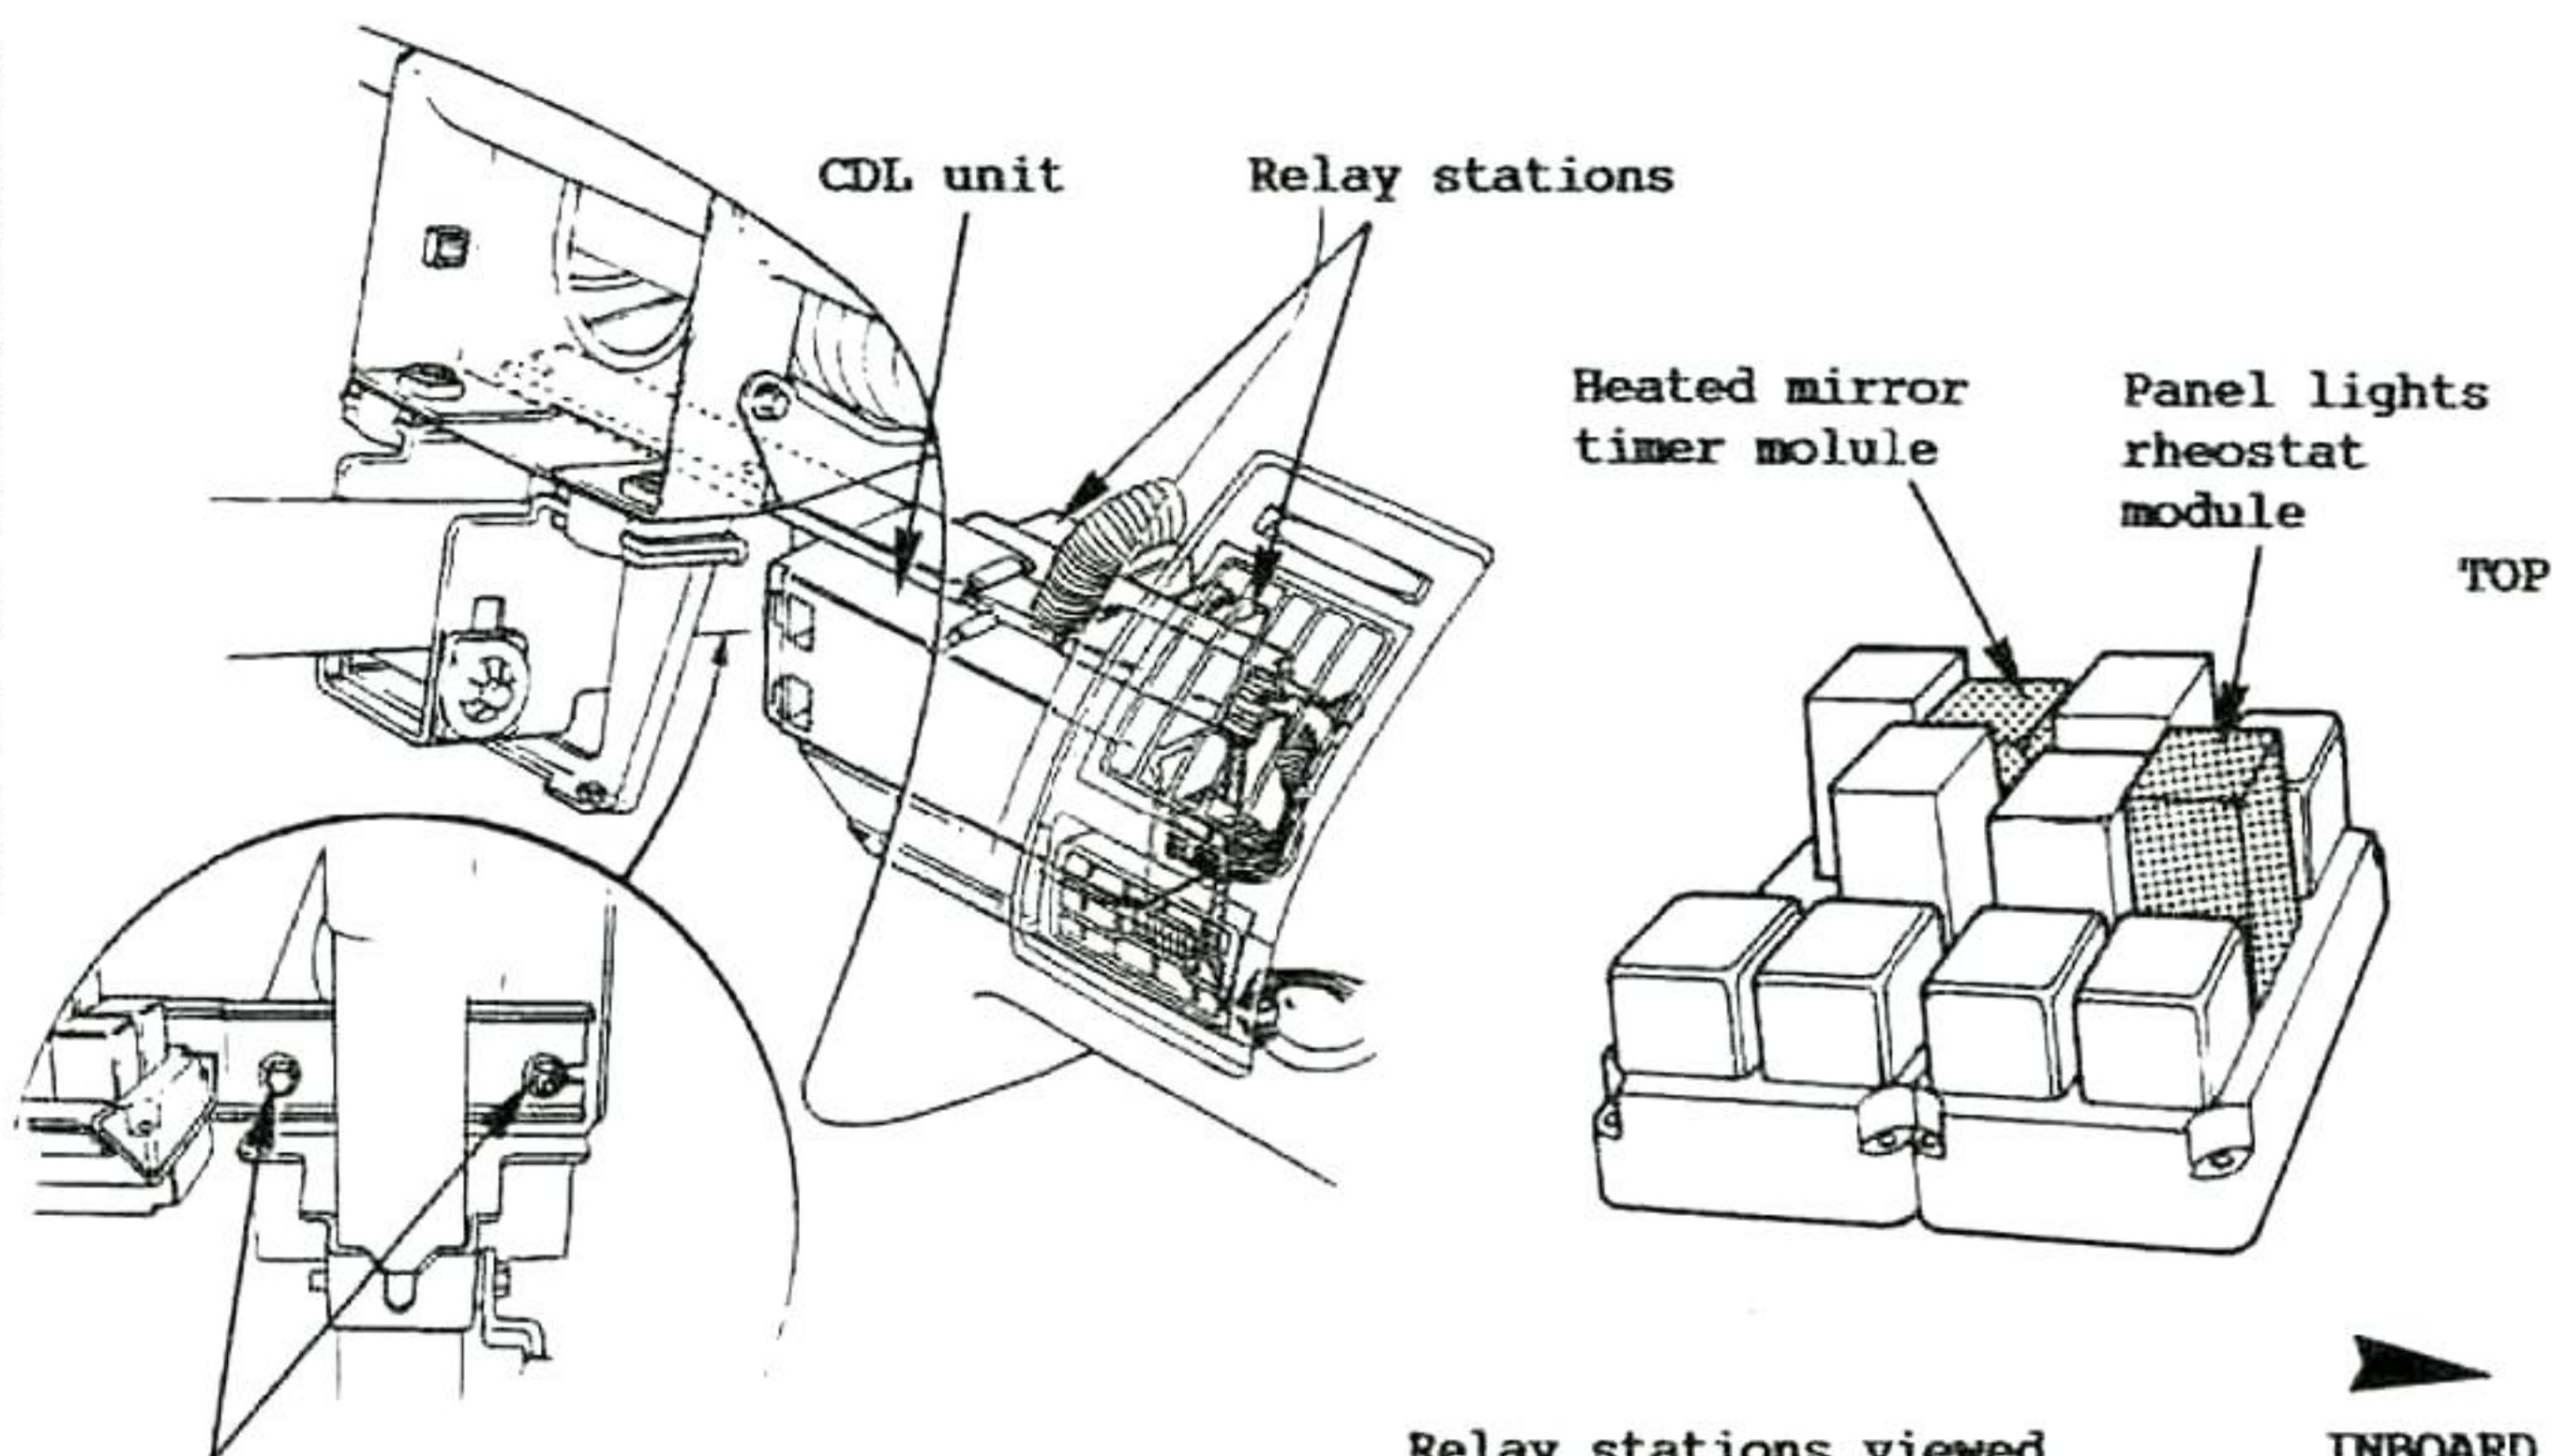
CDL unit/relay station bracket fixings

Relay stations viewed from beneath

Relay stations viewed from cable entry side

Timer module base

6. Refit the relay stations to the mounting bracket, and insert the relays. Refit the bracket assembly to the steering column brace.
7. In the passenger footwell, replace the existing 3A fuse in slot 19 of fusebox A (heated mirror timer), with the new 7.5A fuse.

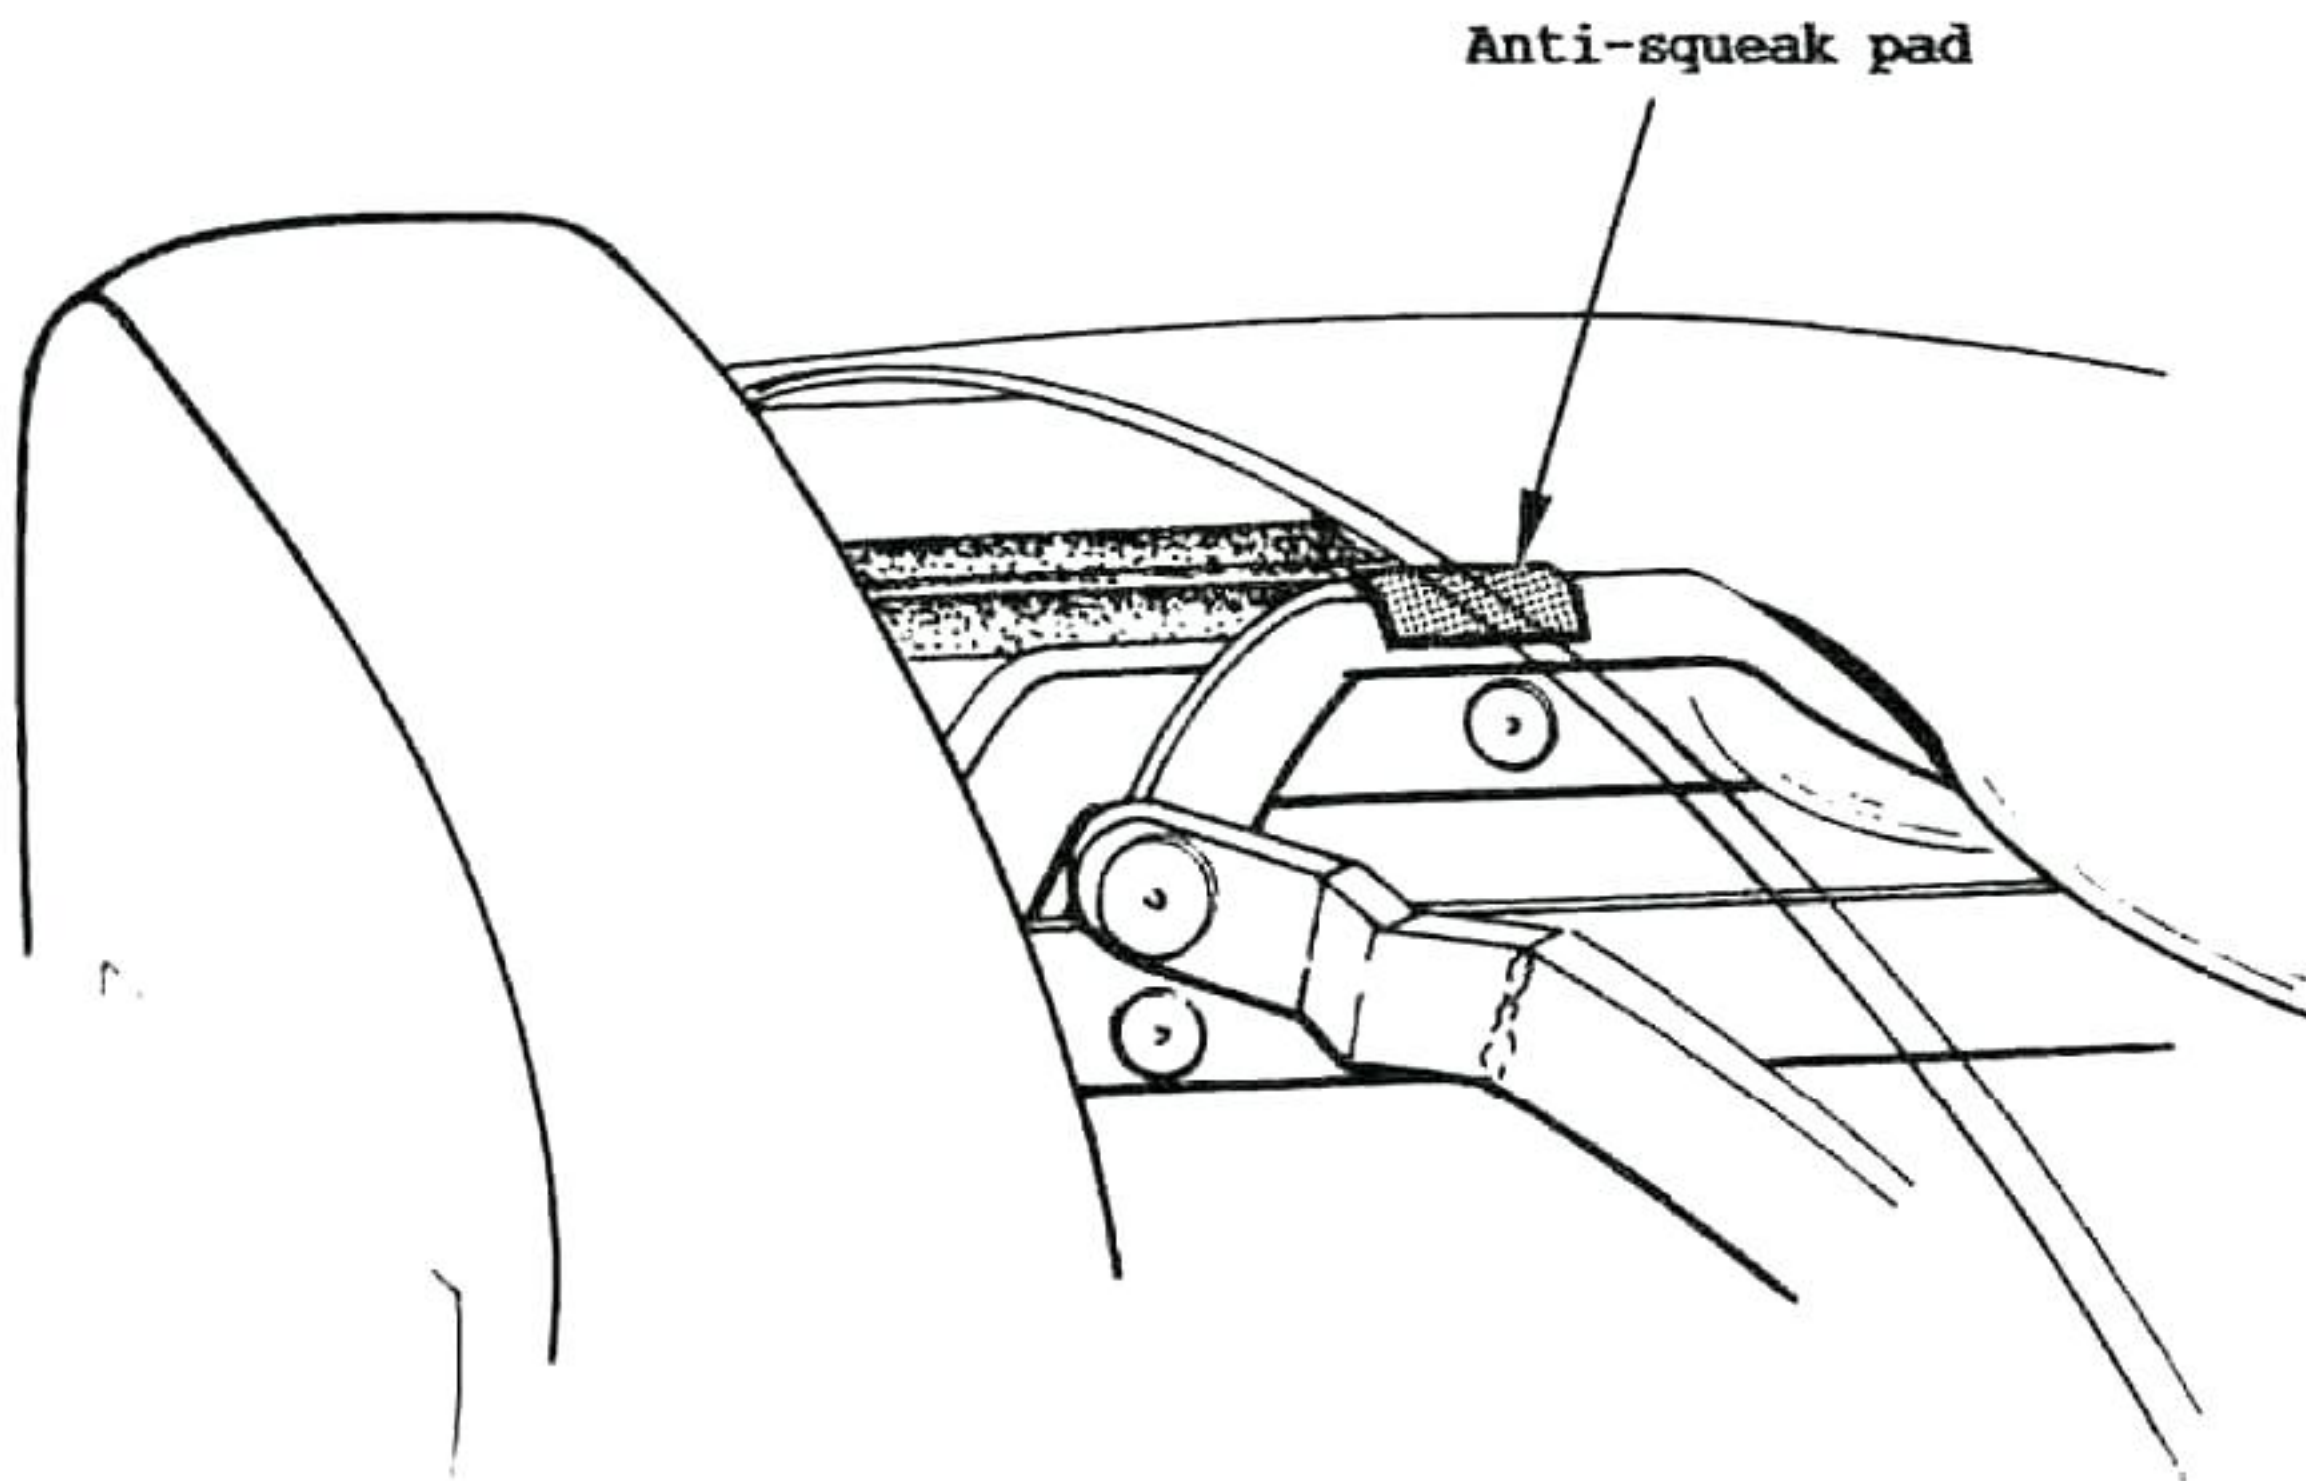
REASON: To prevent squeaking noises caused by contact between front edge of roof stowage lid and soft top support frame.

ACTION: If a squeaking noise on an Elan is found to be caused by the front lip of the roof stowage lid rubbing on the soft top support linkage, a self adhesive anti-squeak pad should be applied to each 'C' link as detailed below:

- At each side of the car, thoroughly clean the top surface of the 'C' link immediately below the front edge of the roof stowage lid, and mark the point of contact.
- Peel off the backing strip and stick a pad onto the roof link centrally about each contact point.
