Lotus Elan M100 Service Bulletins
Series 1 and Series 2 1990 - 1996

SERVICE BULLETIN

TITLE: Replacement of headlamp flap 'J' links.

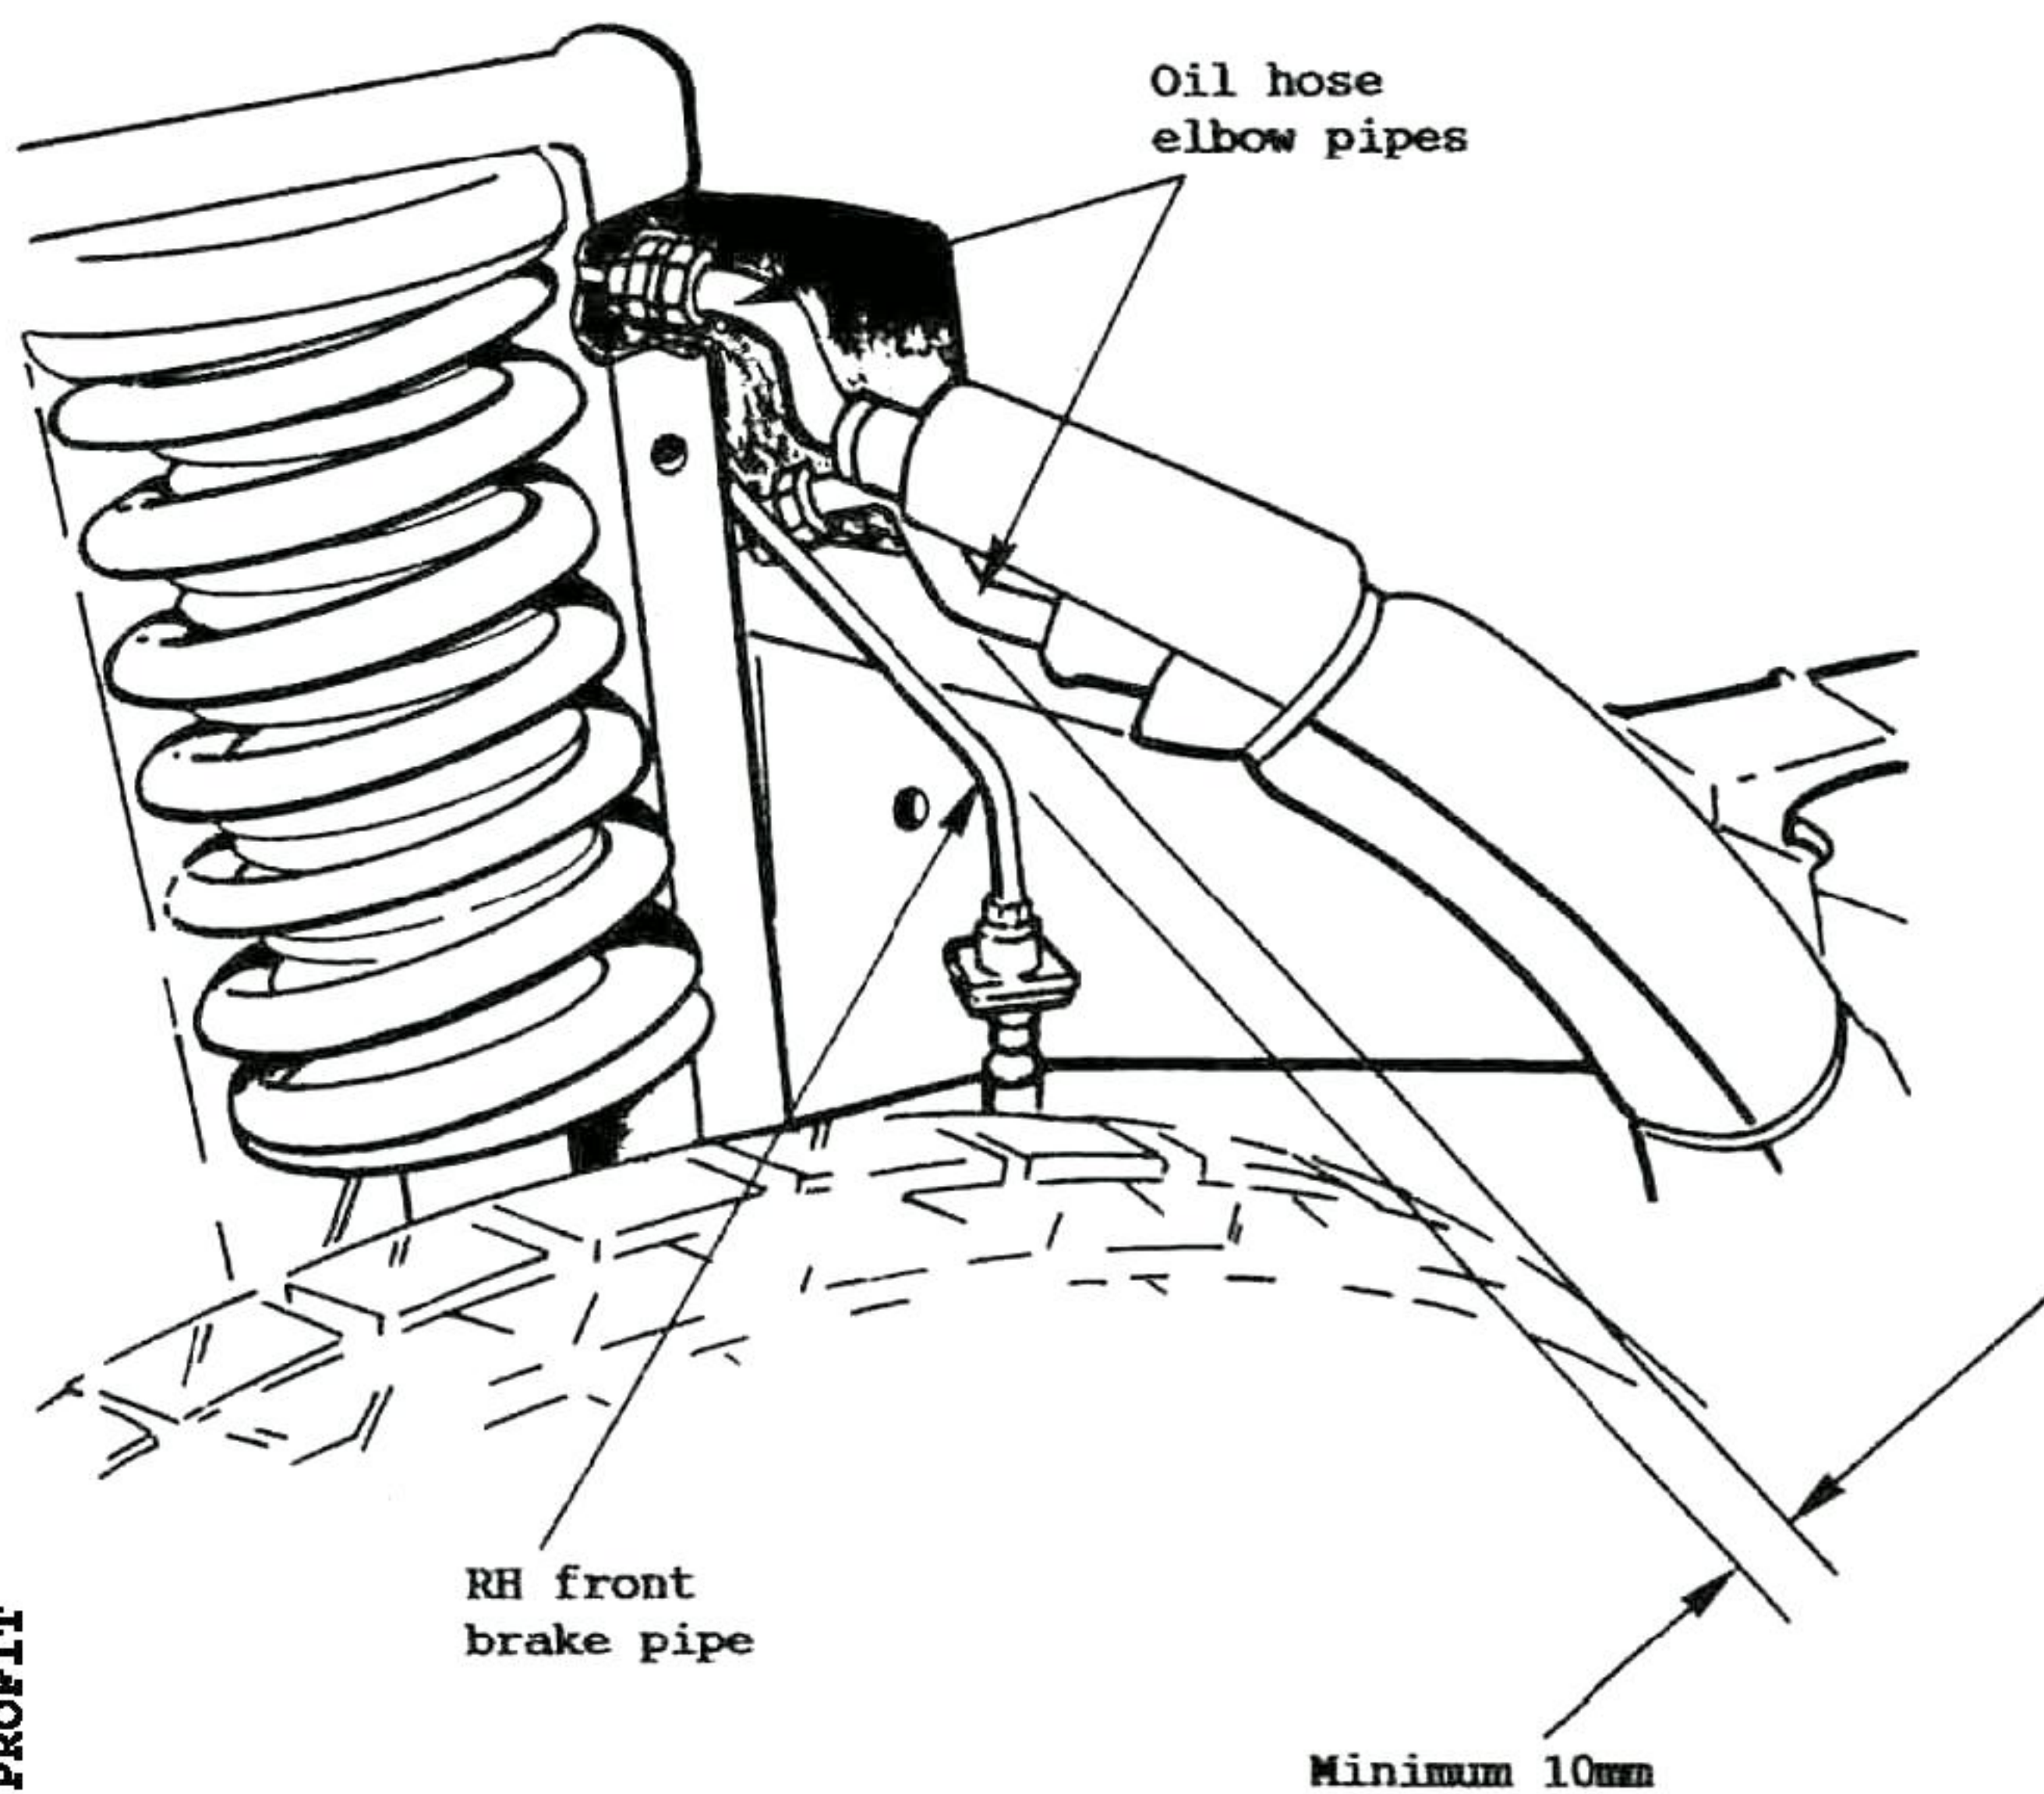
1. Remove the RHF wheelarch liner.
2. Carefully examine the elbow unions and brake pipe for signs of chafing or damage, using a mirror if necessary, and renew components if necessary.
3. Check for oil hose elbow pipe clearance as shown in the illustration. There should be a minimum gap of 10mm between both the elbows and:
 - the brake pipe;
 - the chassis longeron;
 - the body topshell.If necessary, slacken the elbow pipe union nut and reposition the elbow, and/or bend the brake pipe to achieve the specified condition. Torque tighten the union nuts to 27 Nm (20 lbf.ft).
4. Refit the wheelarch liner.

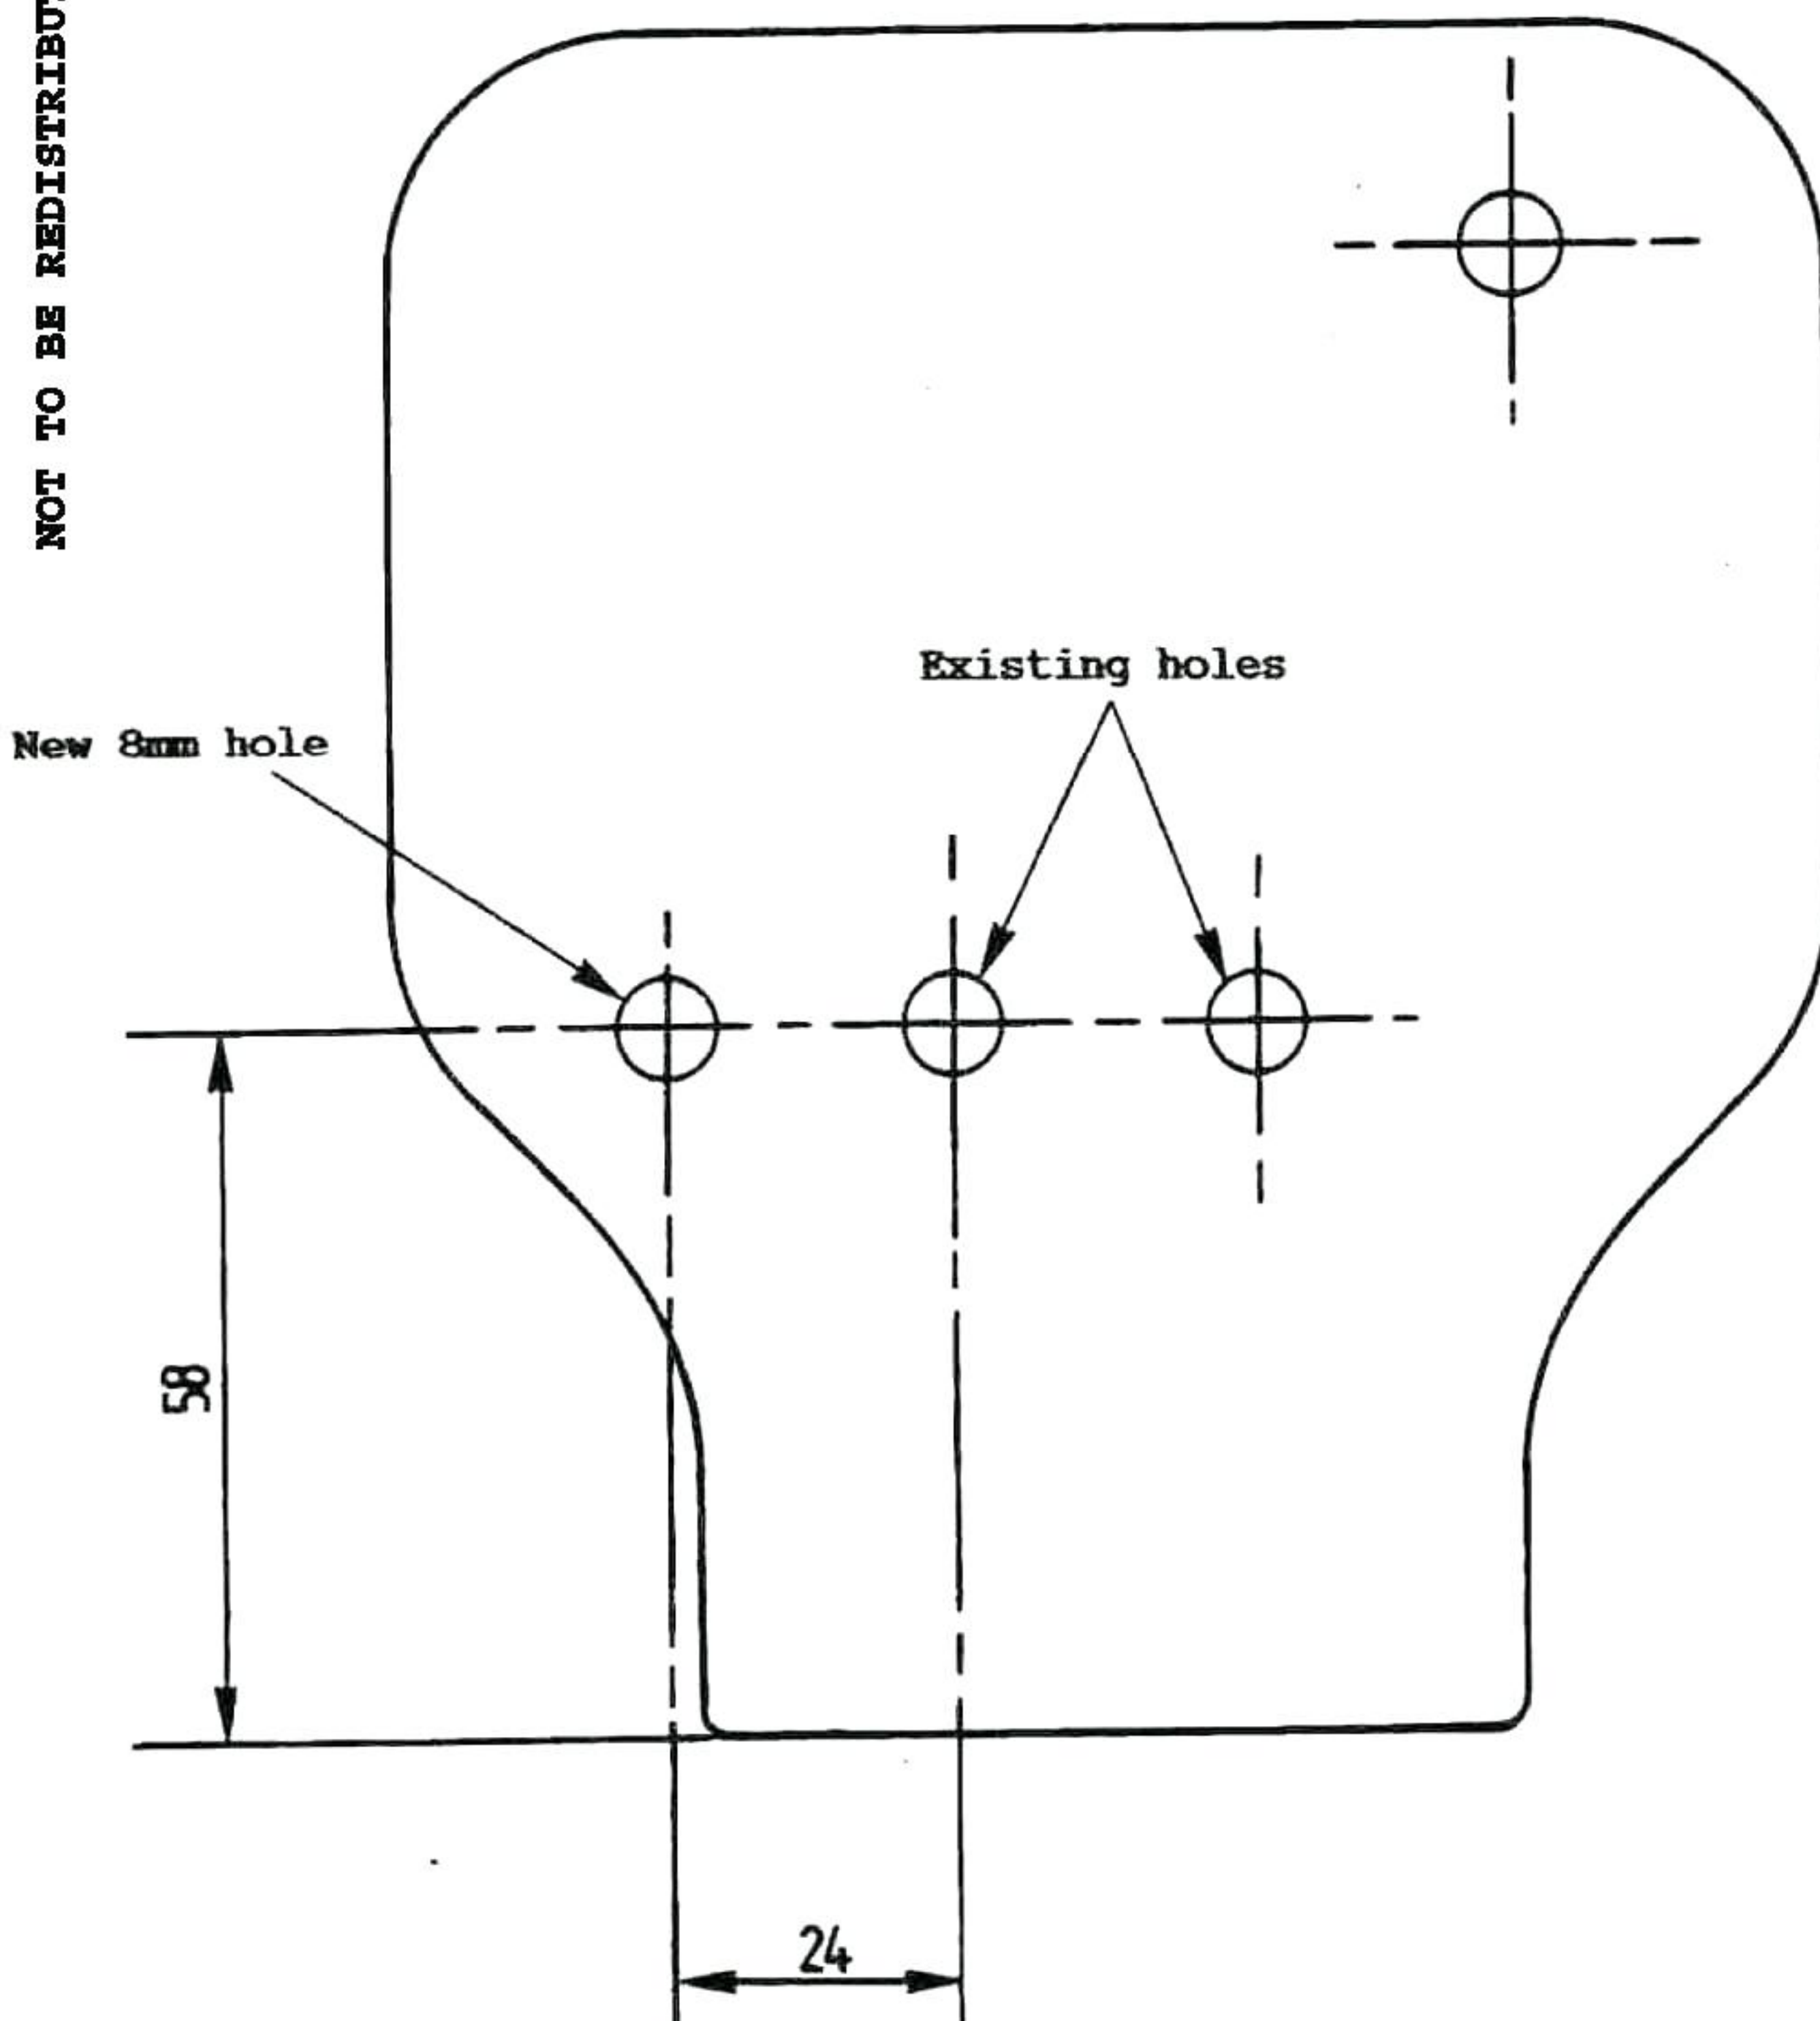
TUNNEL TRAY TEMPLATE

1. Remove the mat from the parking brake lever recess, and by referring to the attached template, check whether the modification has already been carried out, as indicated by the presence of the additional (offset) hole for the microwave sensor LED. If the sensor is found to be fitted in the new offset position, take no further action.

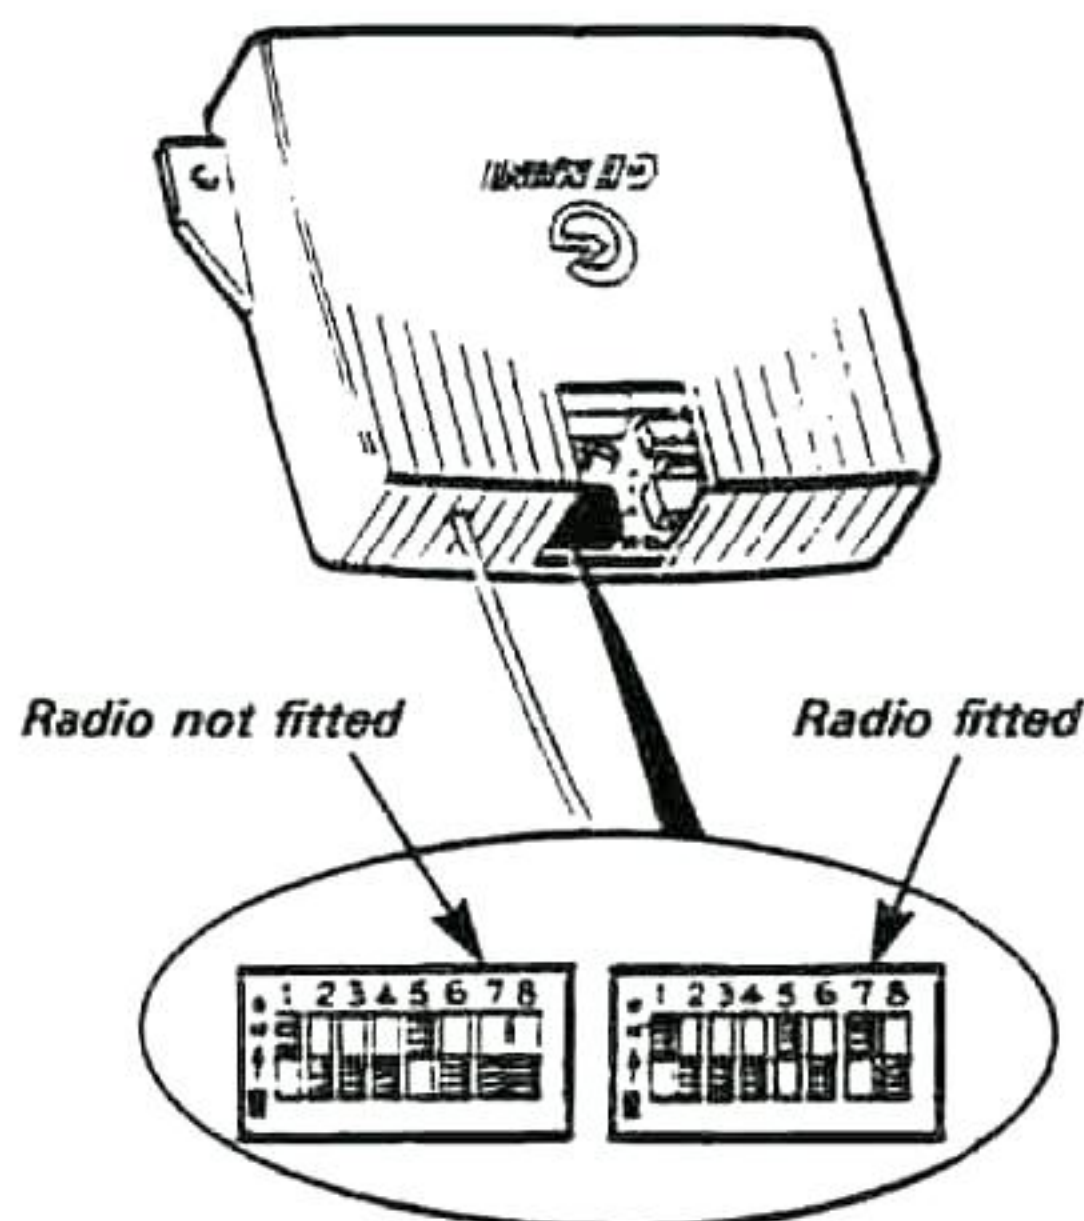
RHD cars: The radio alarm link is already fitted and earthed to the scuttle beam at the right hand end of the row of mini-relays, accessible beneath the binnacle cover. Release the lead and attach to the case of the audio set. Note that the alarm controller radio option switch is already set to the 'on' position.

ACTION: Refer to Service Bulletin 1994/05 page 5.
If fitting audio equipment to a LHD car built with the 'no radio' option, from VIN R 6165 (Sept. '94), it is no longer necessary to re-programme the alarm controller as specified on S/B 1994/05.
For clarification, alarm connection details follow for all Elan S2 variants built without audio equipment:

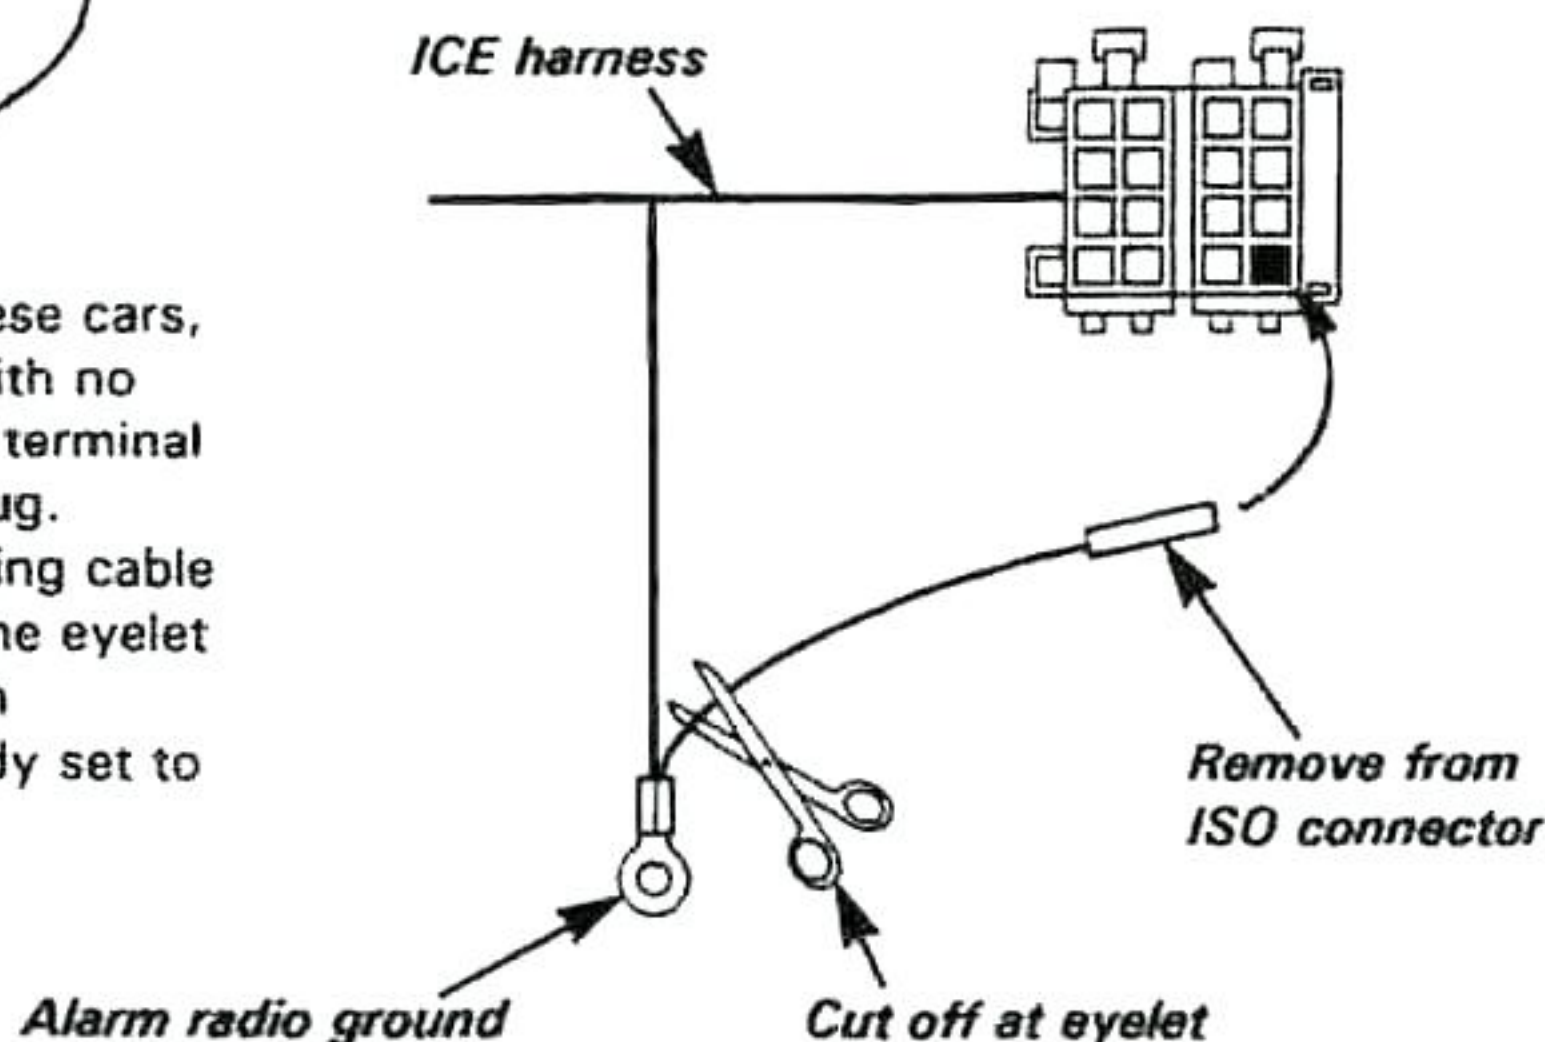
LHD cars (from VIN R 6165): On these cars, the radio harness eyelet is earthed (with no radio) via a bridging cable to an earth terminal in the radio harness ISO connector plug. When fitting a radio, unplug the bridging cable and cut off from the eyelet. Attach the eyelet to the radio case. Note that the alarm controller radio option switch is already set to the 'on' position.

LHD cars (prior VIN R 6165): Obtain radio alarm link A082M4989F and plug into the brown/black lead from the I.C.E. harness. Attach the lead to the case of the audio set. The alarm controller must then be re-programmed: Drop the glovebox down for access to the controller, and unclip the small cover on the top of the controller case. Move switch no.7 (radio option) to the down ('on') position, and refit the cover.

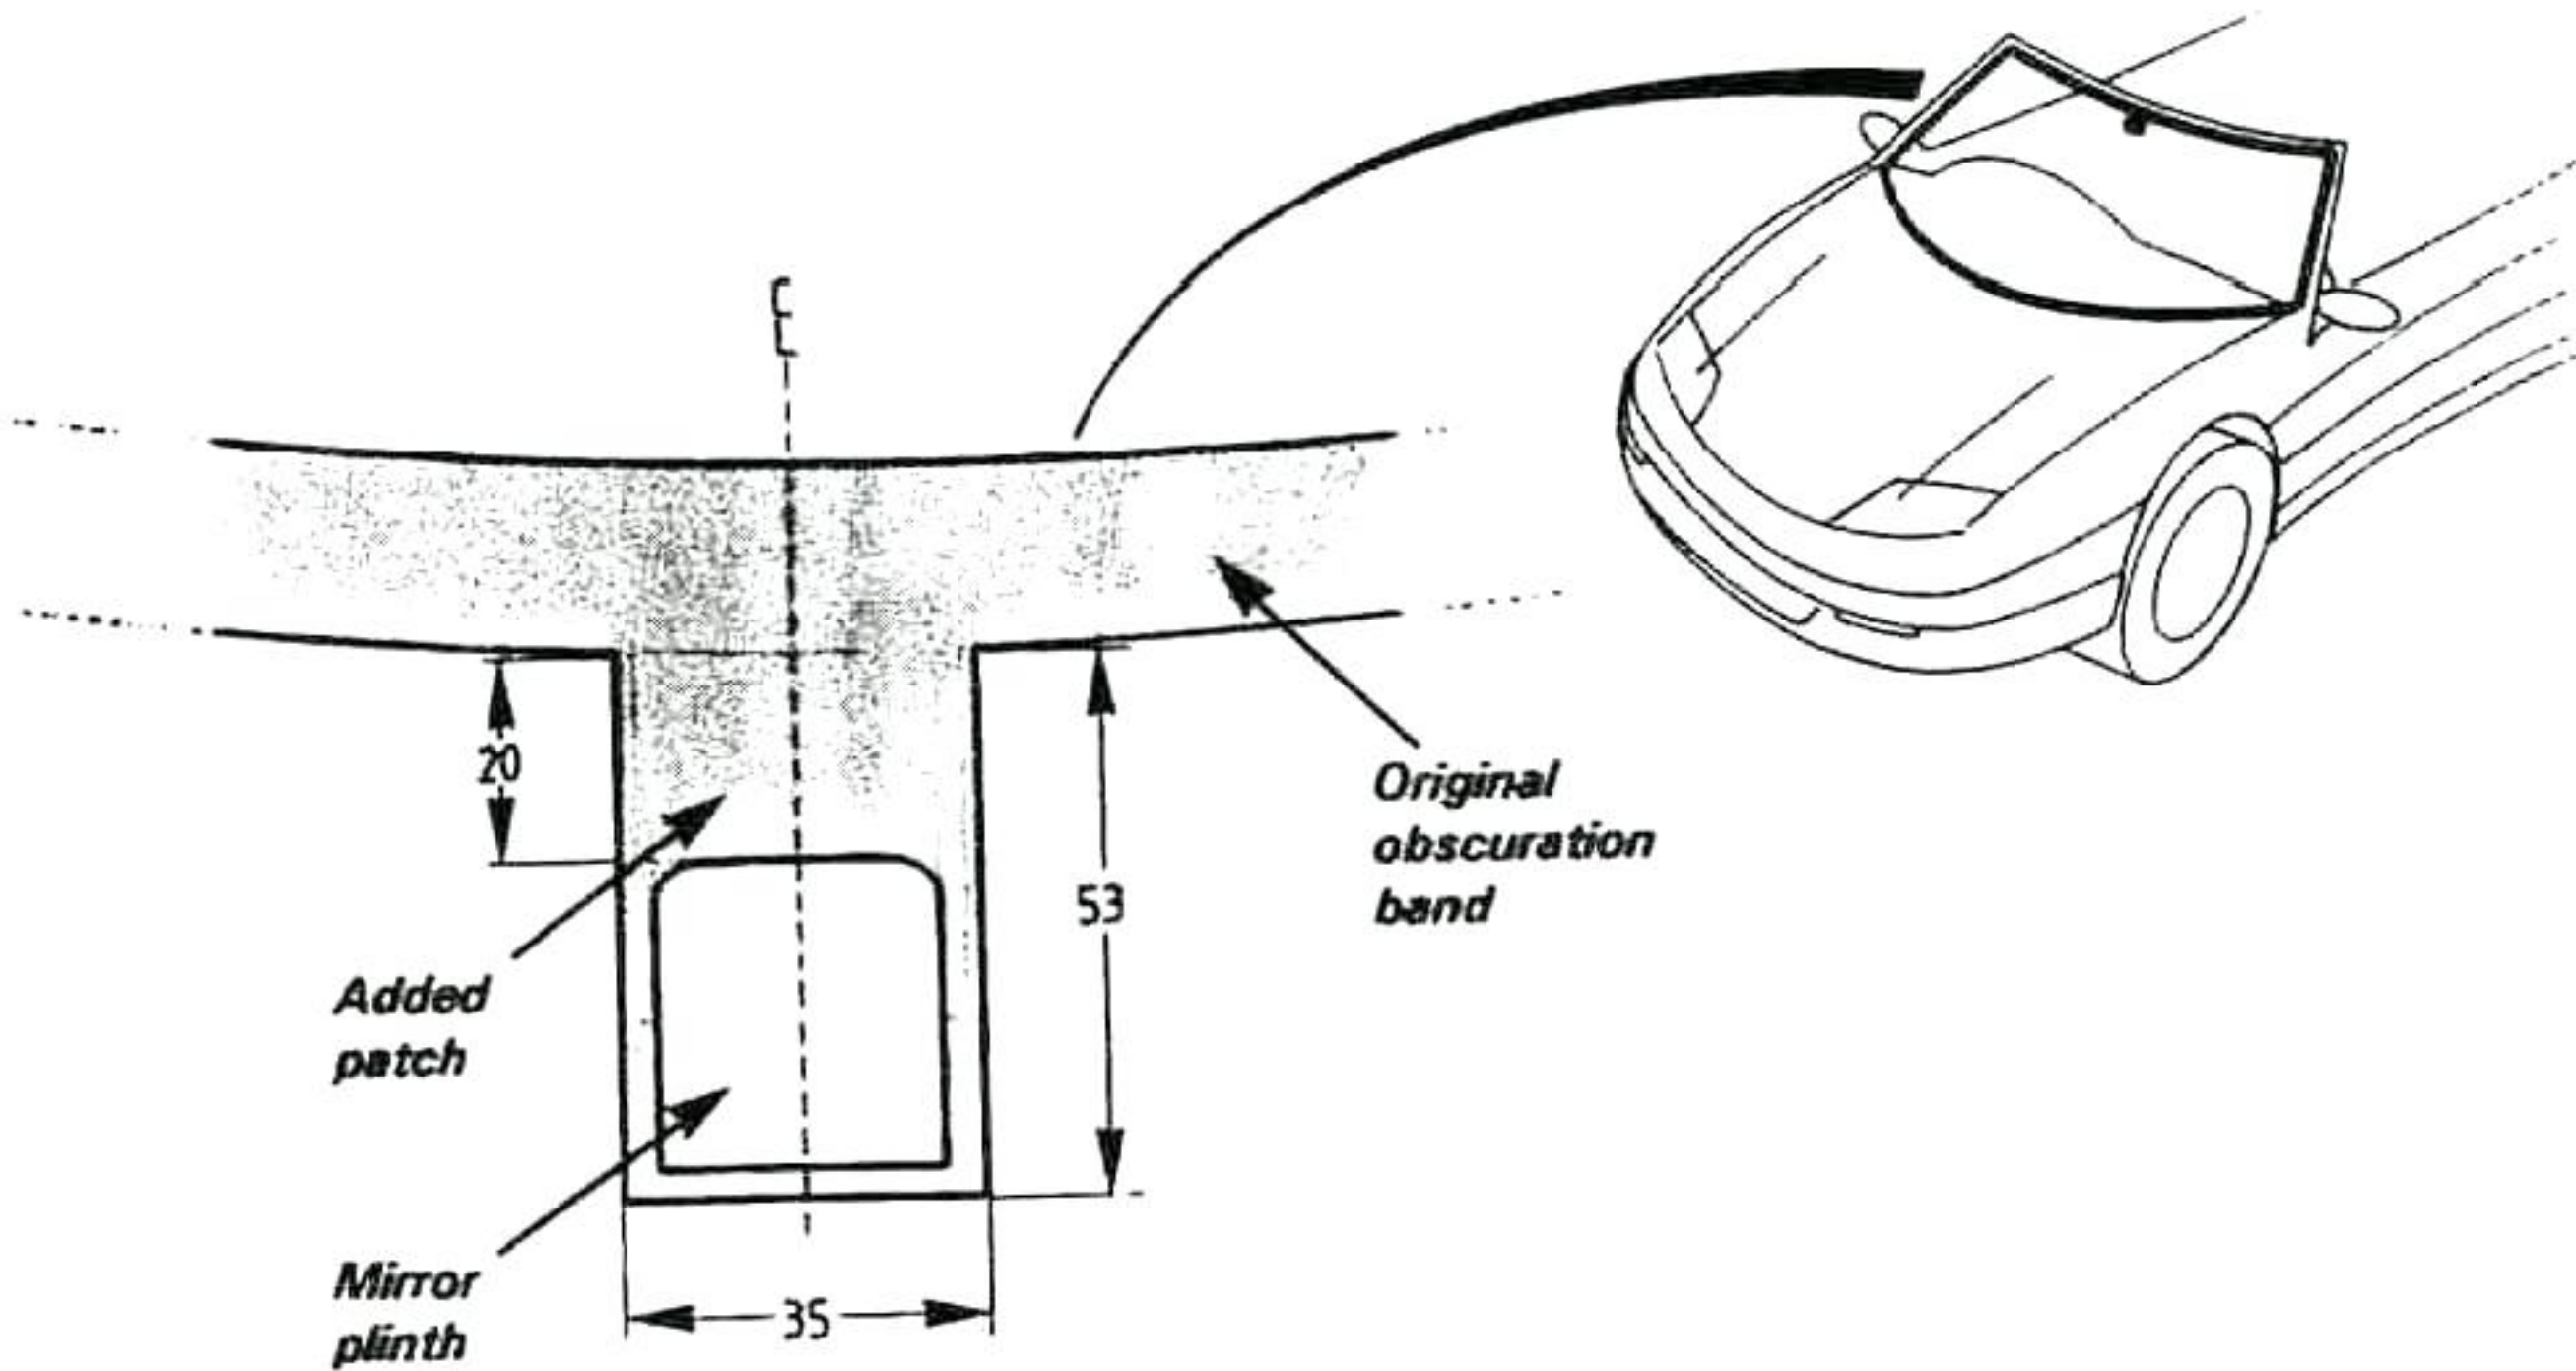
REASON: The obscuration band applied to the inside periphery of the windscreen by the screen manufacturer has been revised in order to increase resistance to stress related effects. As a consequence of this action, the patch obscuring the interior mirror plinth has been deleted. When fitting a replacement windscreen, this patch must be manually added using Betaseal primer.

ACTION: When fitting a windscreen to an Elan S1 or S2, refer to section BK.15 of the Elan Service Notes manual, but delay the glueing of the interior mirror plinth until after the Betaseal primer has been applied, with the following addition:

Use masking tape to mark out a rectangular patch extending down from the centre top of the screen obscuration band as shown in the diagram below. When the primer has fully dried, continue with the mirror plinth bonding as previously specified.

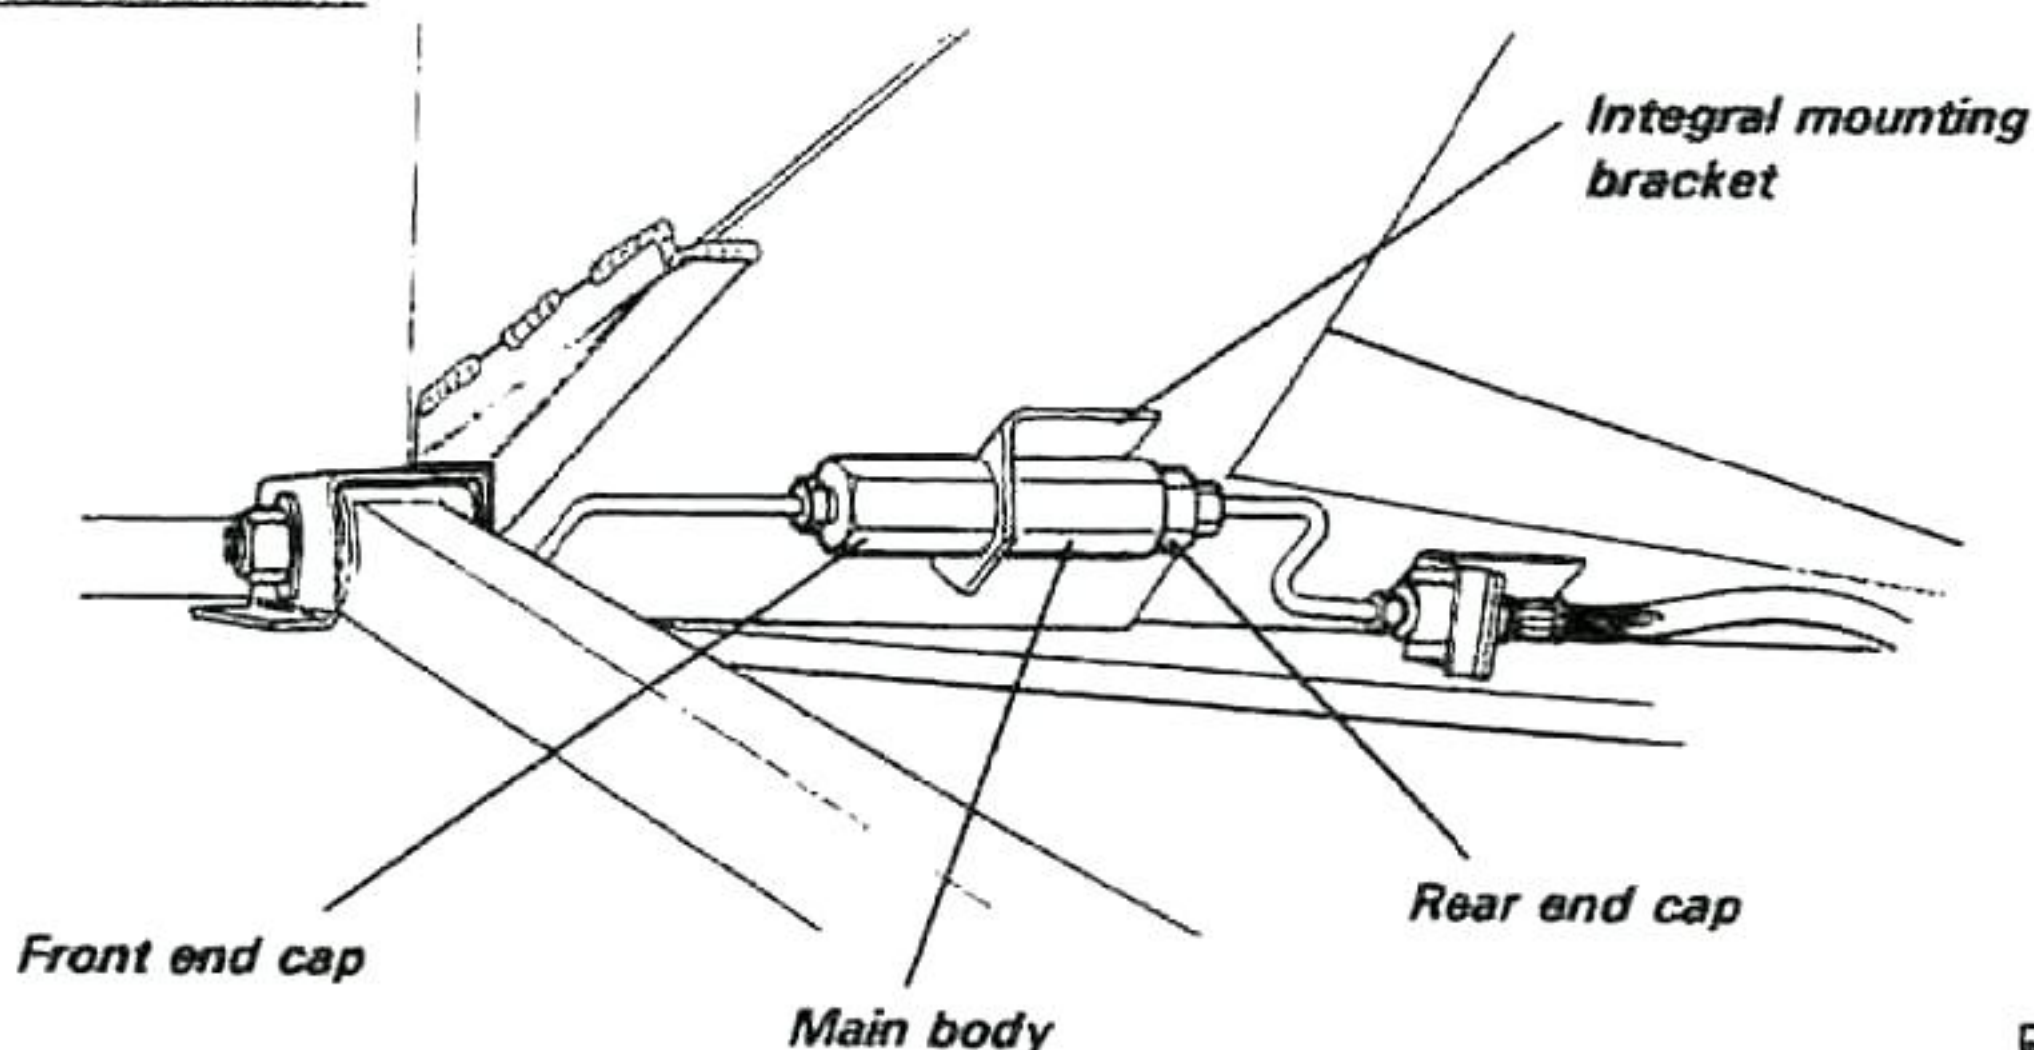
LH side shown

TITLE: Mis-diagnosis of leaking brake proportioning valves.

REASON: To reduce needless replacement of valves.
The brake pressure proportioning valves fitted to the rear brake circuits of Elan models, are sometimes erroneously diagnosed as leaking, due to their 'wet' appearance. This wetness is normal on a newly installed valve, and is due to the discharge of surplus polyalkylene glycol assembly fluid used during manufacture of the valve.

- Thoroughly degrease and clean the area before monitoring the appearance of any further wetness.
- Assess the colour of any 'leaked' fluid; assembly fluid is clear, brake fluid is amber.
- Check the level of fluid in the brake fluid reservoir; the level should fall progressively towards the 'min' mark as the pads wear in service.

If submitting a warranty claim, the exact source and nature of the leak must be specified. Claims will not be paid if returned units are found to be fault free.
